090810CBB1946

This in-depth-investigation was initiated as follow-up to a CPSC generated incident report indicating that a consumer residing in a community allegedly containing Chinese drywall has reported that he has not experienced any obvious health related problems nor has had issues with malfunctioning appliances in his home.

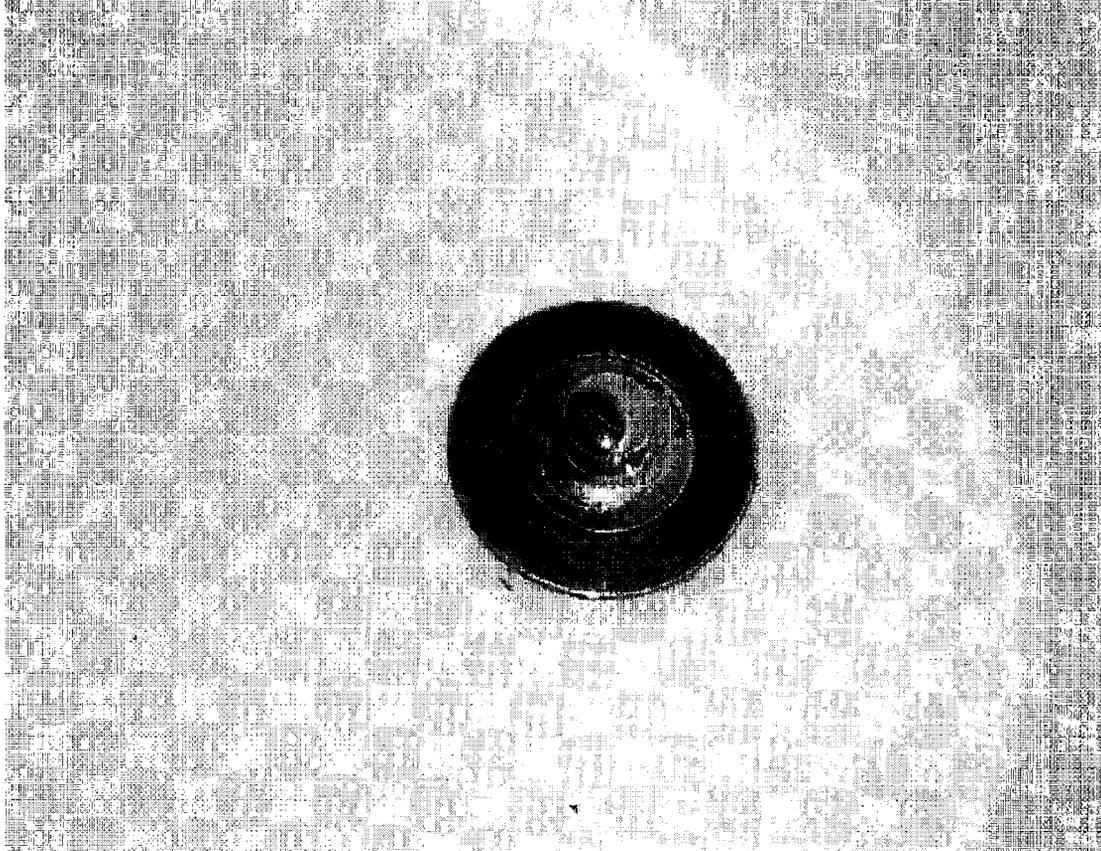
Photo 2 – View of corrosion on drain in bathtub that has never been used

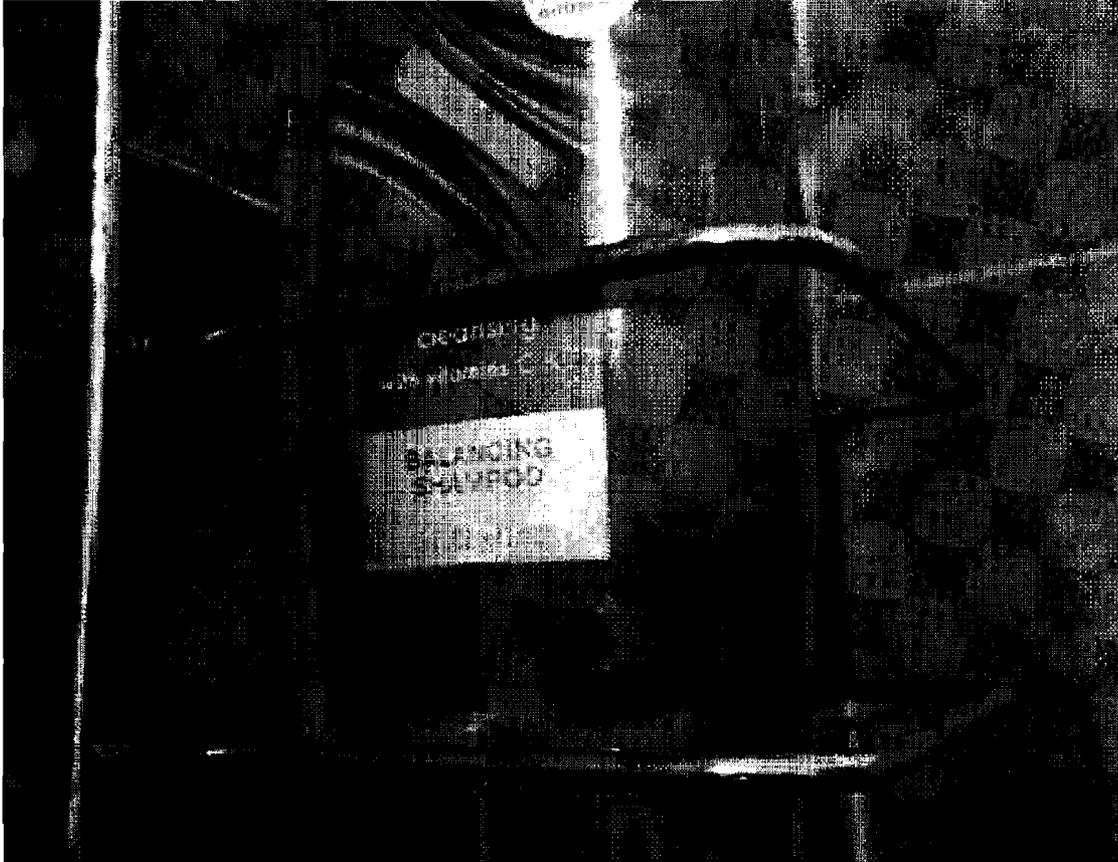
Photo 3 – View of corrosion on shower shelf

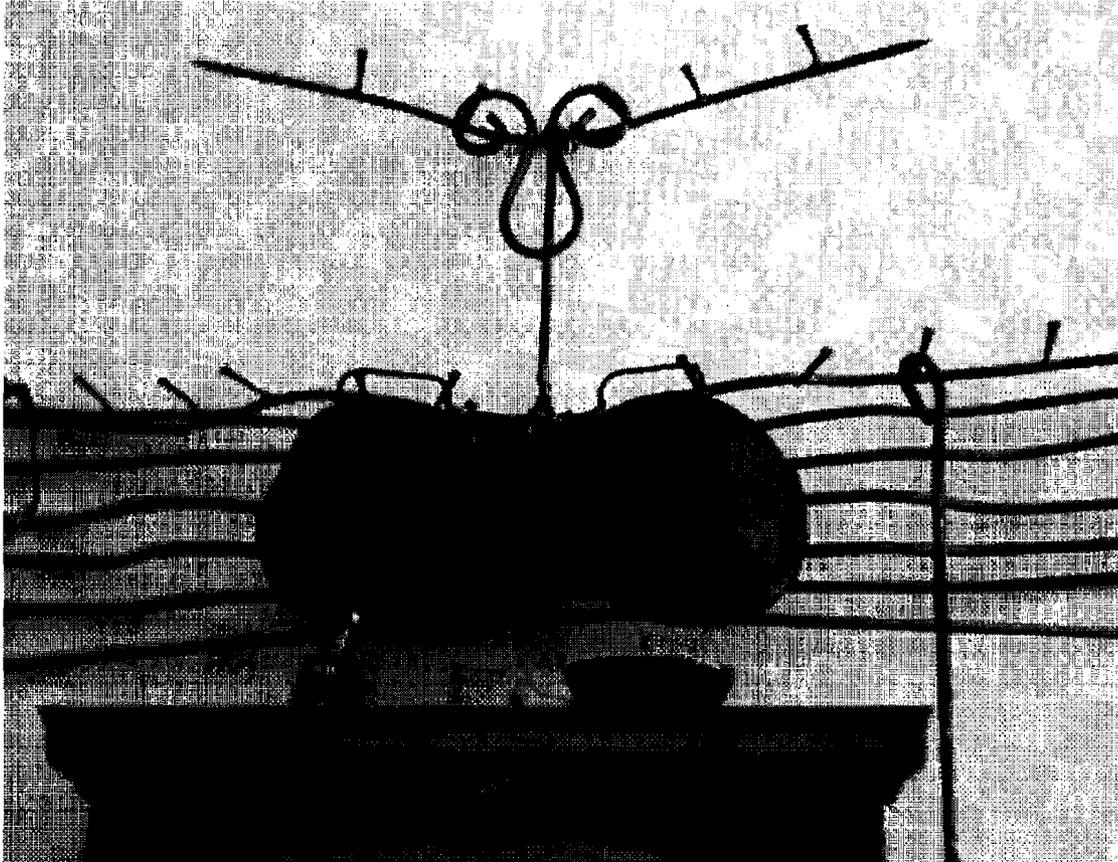
The homeowners' pointed out that a copper breast plate artwork that was in a show in 2007 has also turned black. The homeowner provided a copy of a newspaper article showing the art piece (Attachment 3). It was dated July 12, 2007. The homeowners brought the piece of artwork back to their home and since then, it has corroded and has turned the copper black.

Photo 4 – View of copper artwork showing black corrosion

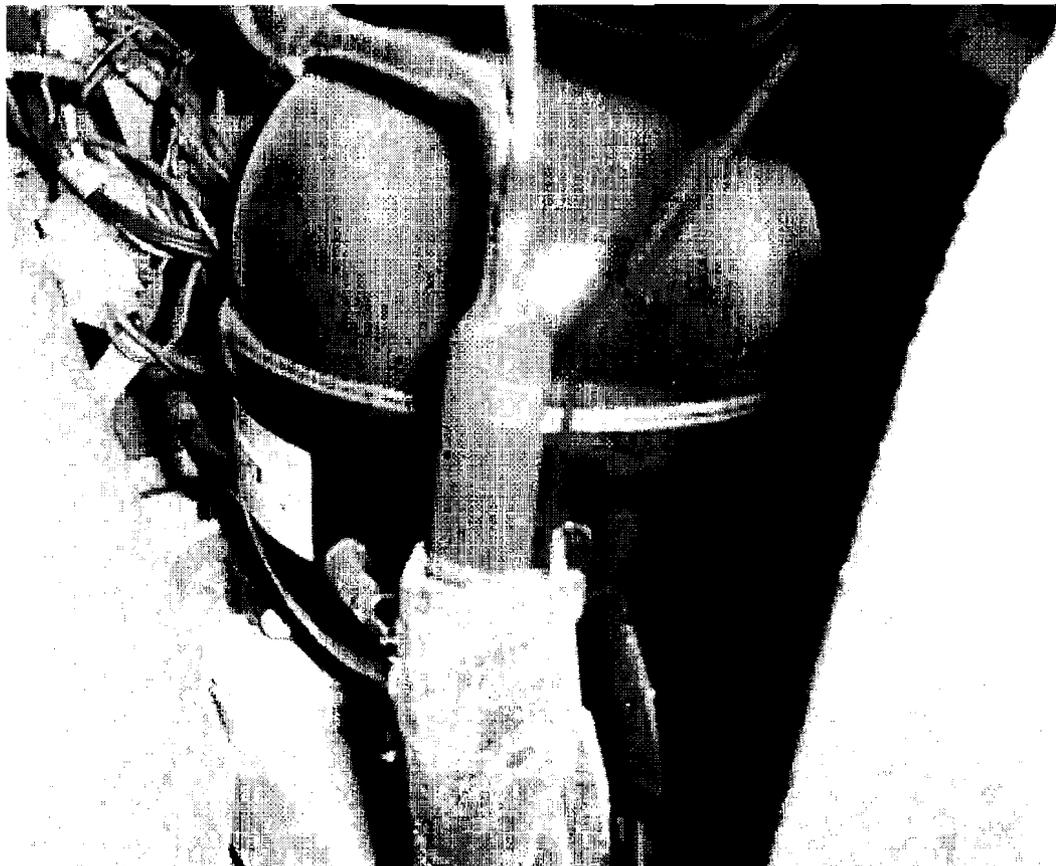
Photo 5 – View of corrosion on pipe on back of refrigerator

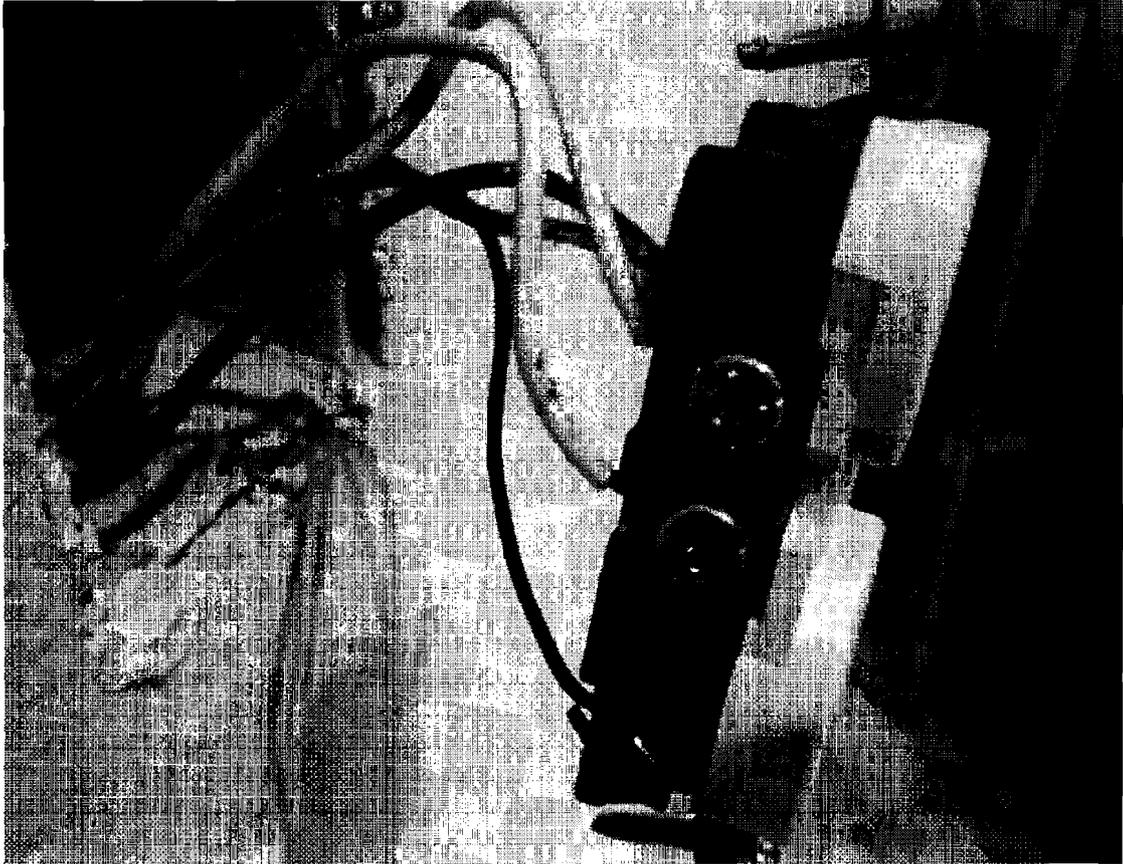
Most of the outlets were checked by the engineers. All of the ground wires that were checked showed signs of corrosion (See Attachment 1, Photo 6).

Photo 6 – View of corrosion on ground wire of the outlet

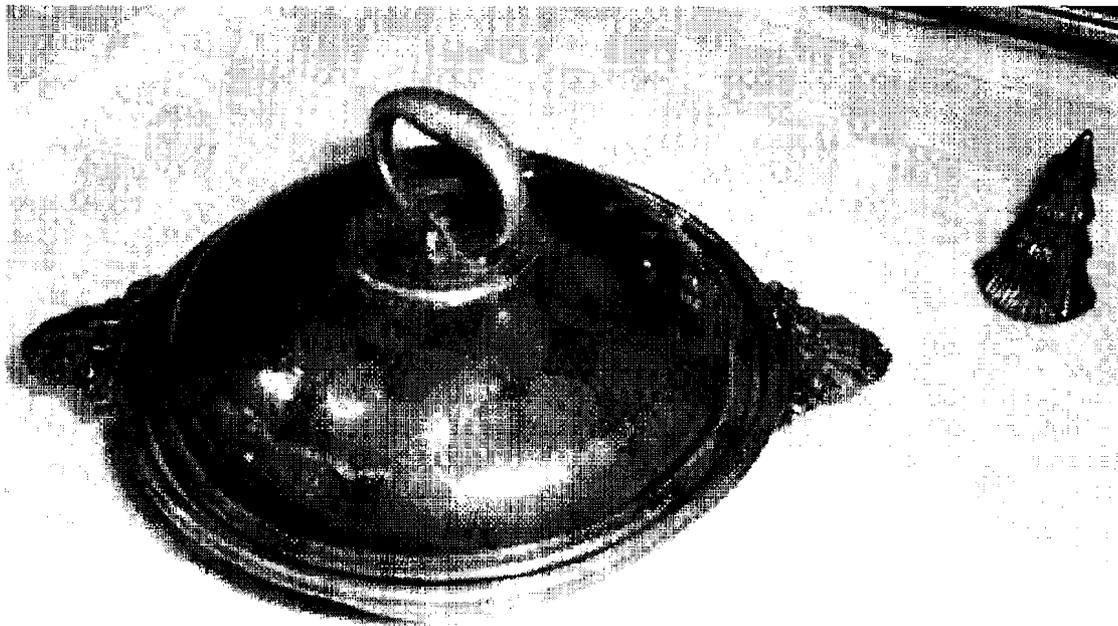
Photo 7 – View of corrosion on silver bowl and Christmas tree decoration

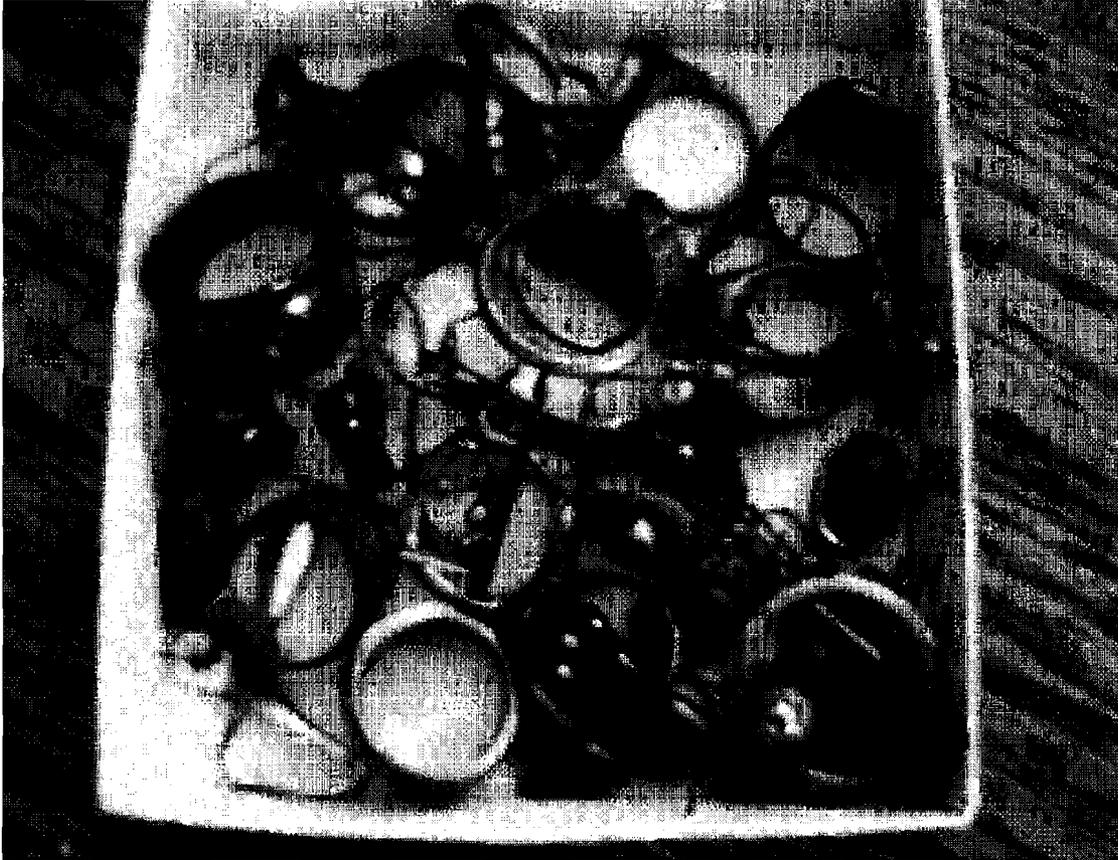
Photo 9 – View of corrosion on jewelry

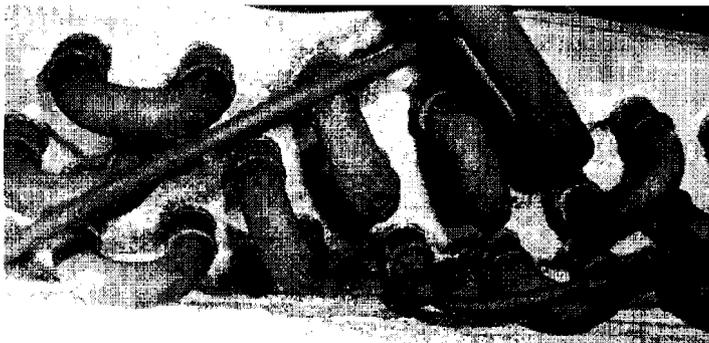
The home had two air conditioner systems and the coils to the upstairs unit were replaced on 1-14-2008 and 7-08-2008. The coils to the downstairs unit were replaced on 12-22-2007 and 8-25-2008. The repair technician could not understand what could cause the corrosion to the evaporator coils but guessed that sulfur could cause the corrosion. Photographs of the newer coils which show corrosion are included in the exhibits.

Photograph of recent corrosion to the downstairs A/C evaporator coils.

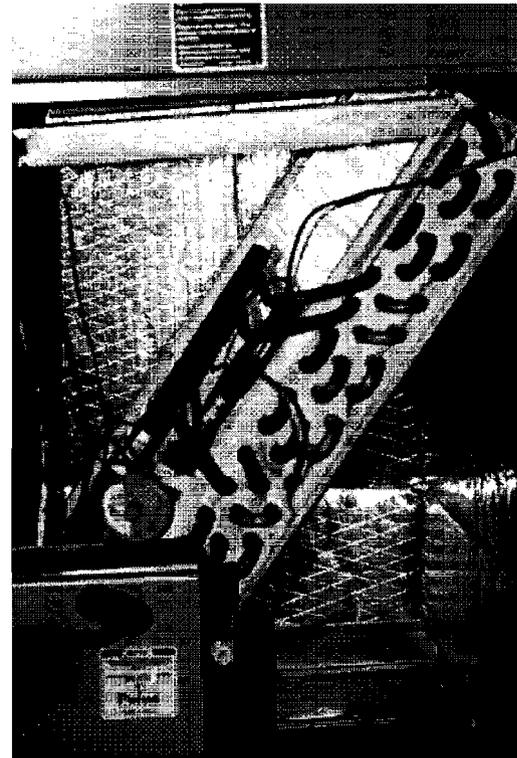
- Replaced evaporator coils in AC units 5 times in three years.
- The curved coils in this photo should be copper.
- In May '09, the system froze up and no longer works.

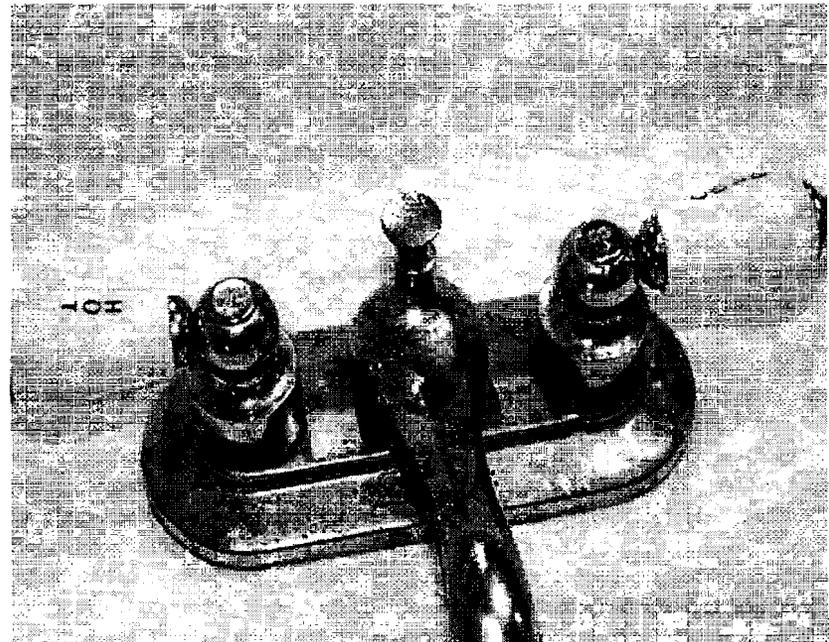
- Plumbing fixtures corroded within 6 months of moving into home.
- This photo is from our children's bathroom. They brushed their teeth here for 3 years.

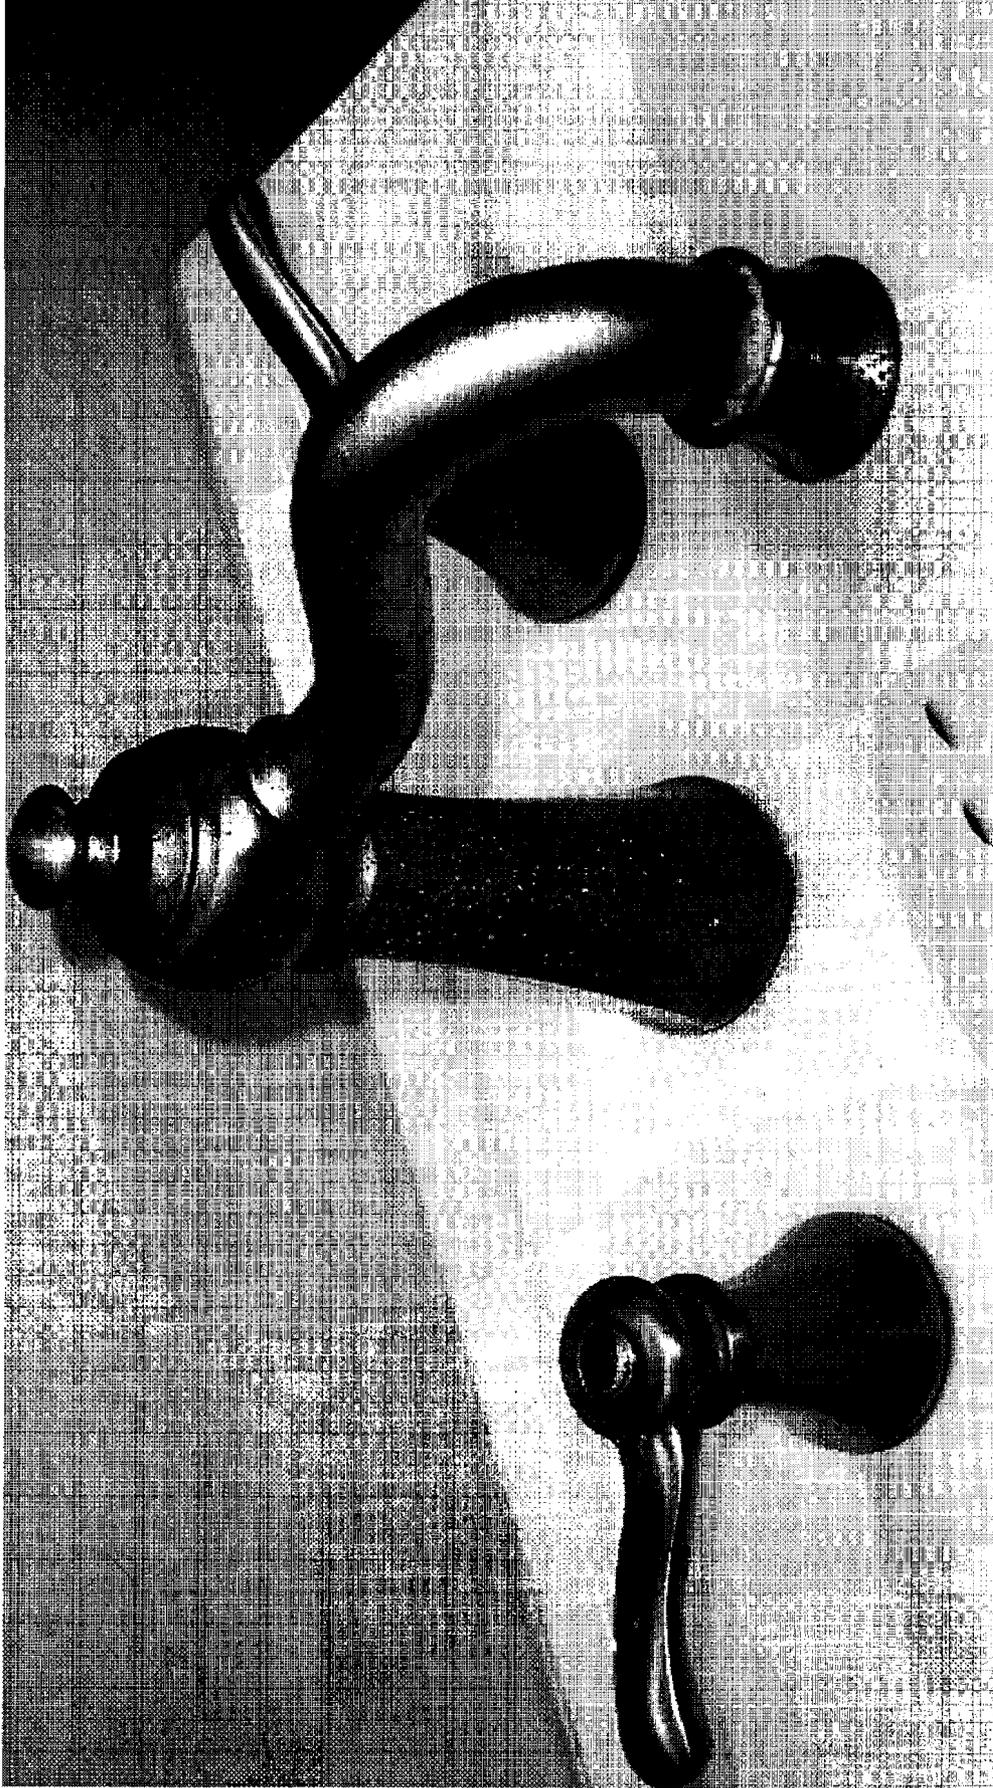
Photograph of corrosion on a bathroom chrome fixture.

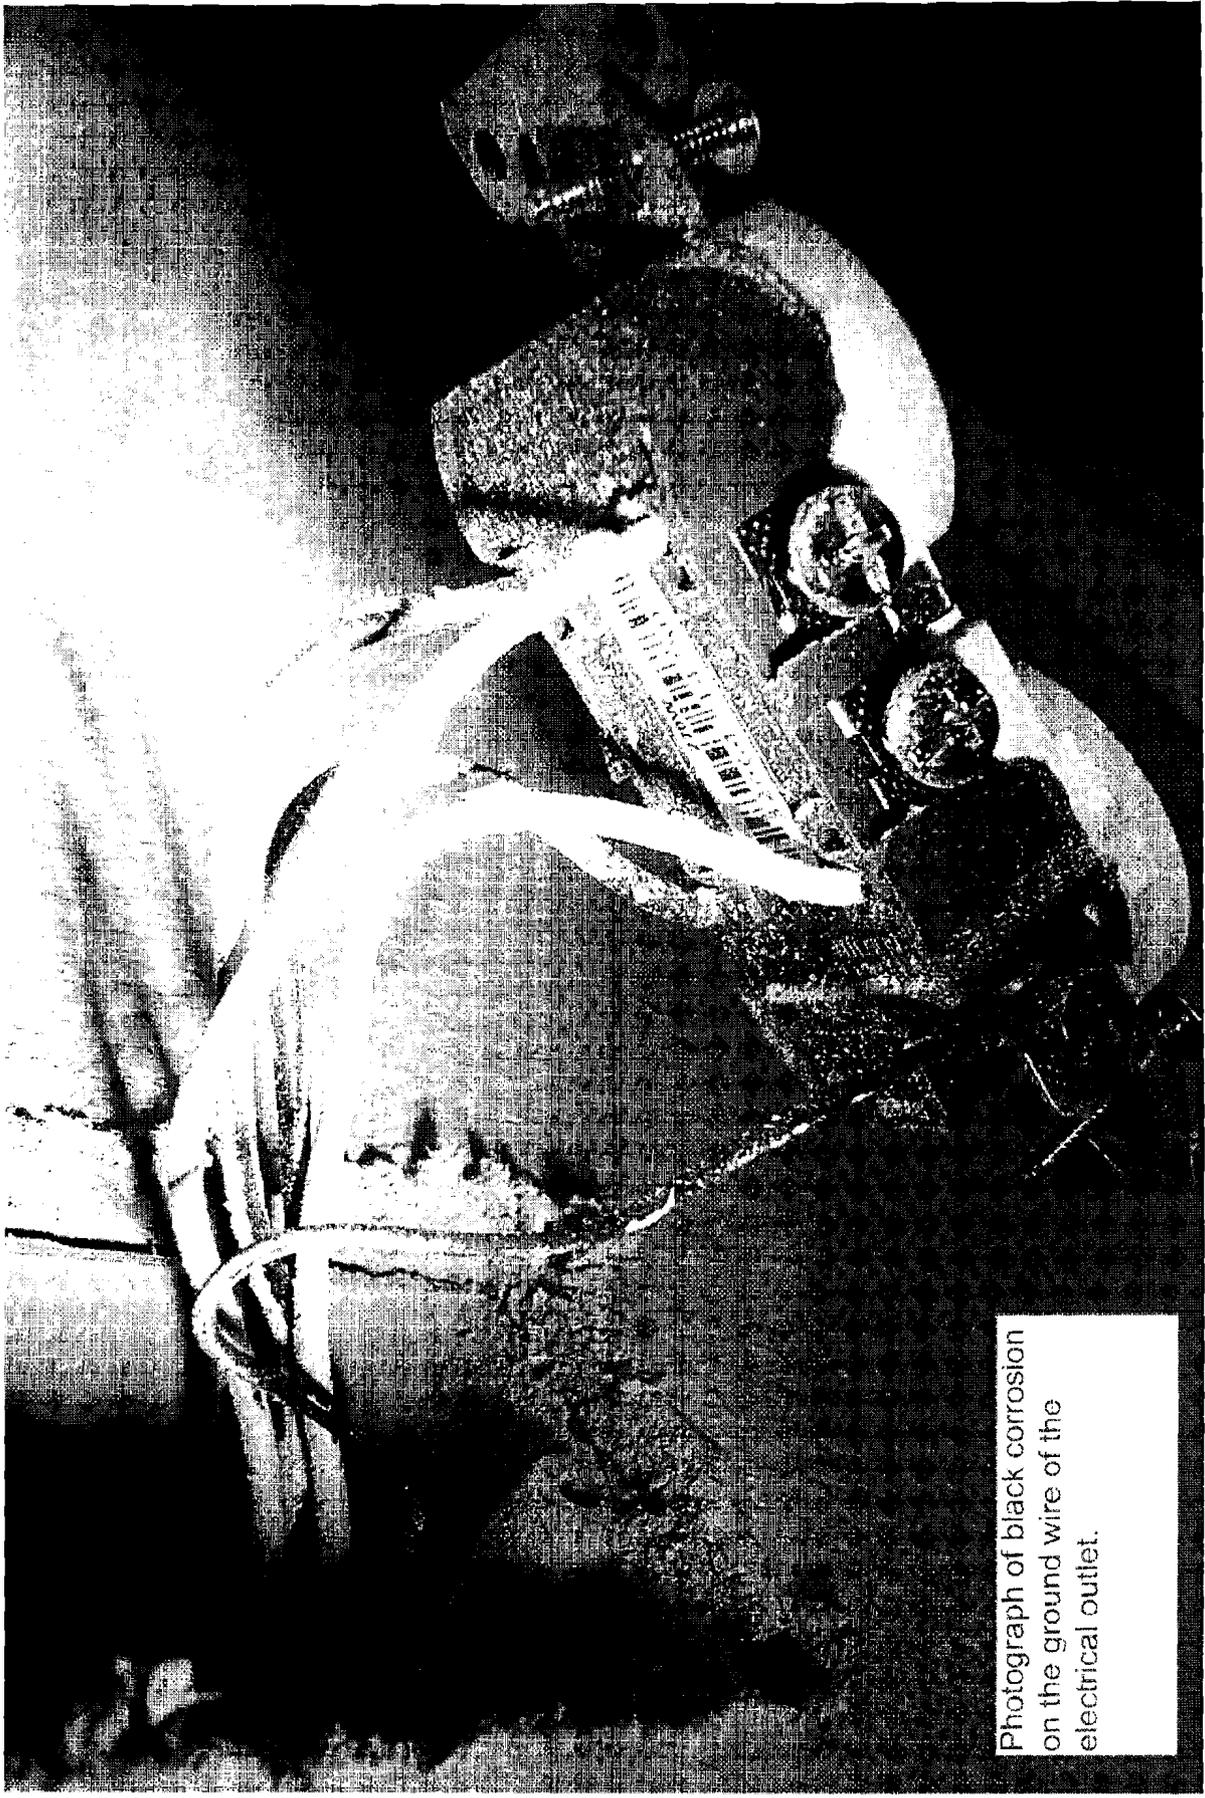
Photograph of black corrosion on the ground wire of the electrical outlet.

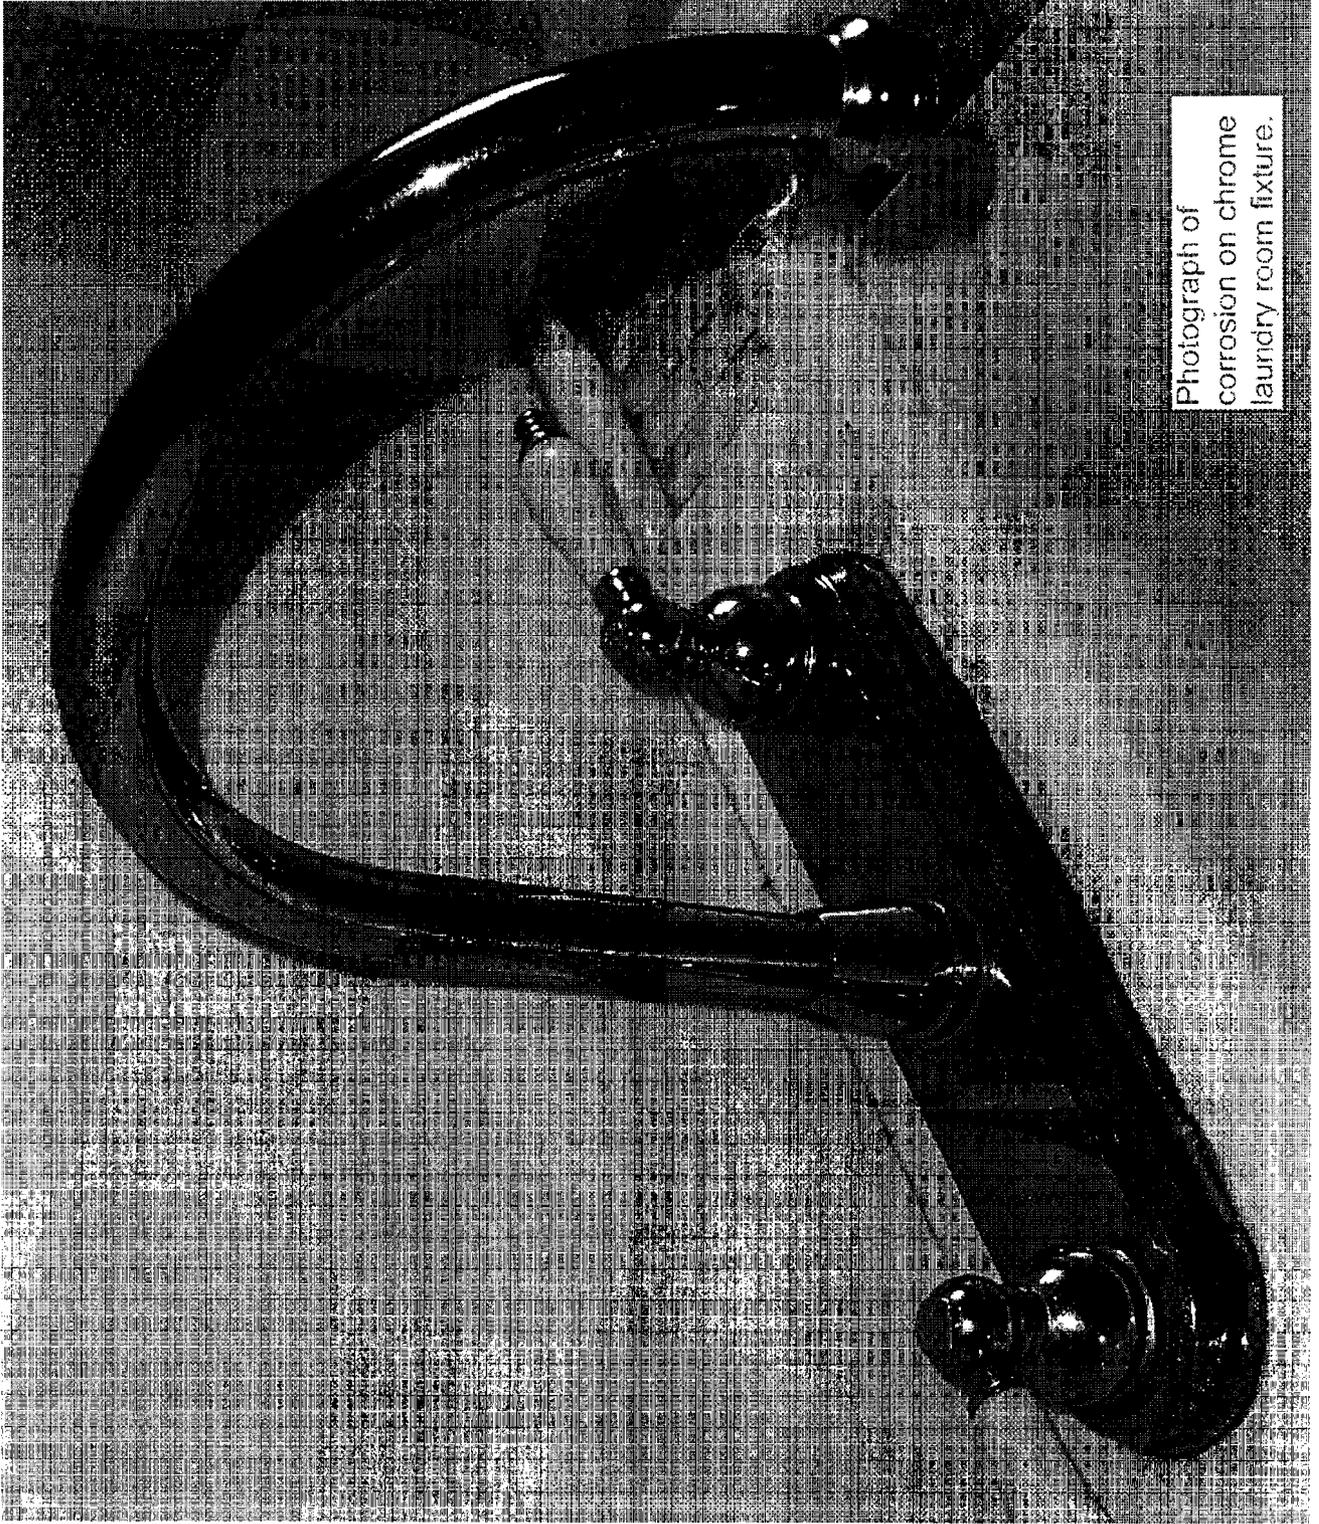
Photograph of corrosion on chrome laundry room fixture.

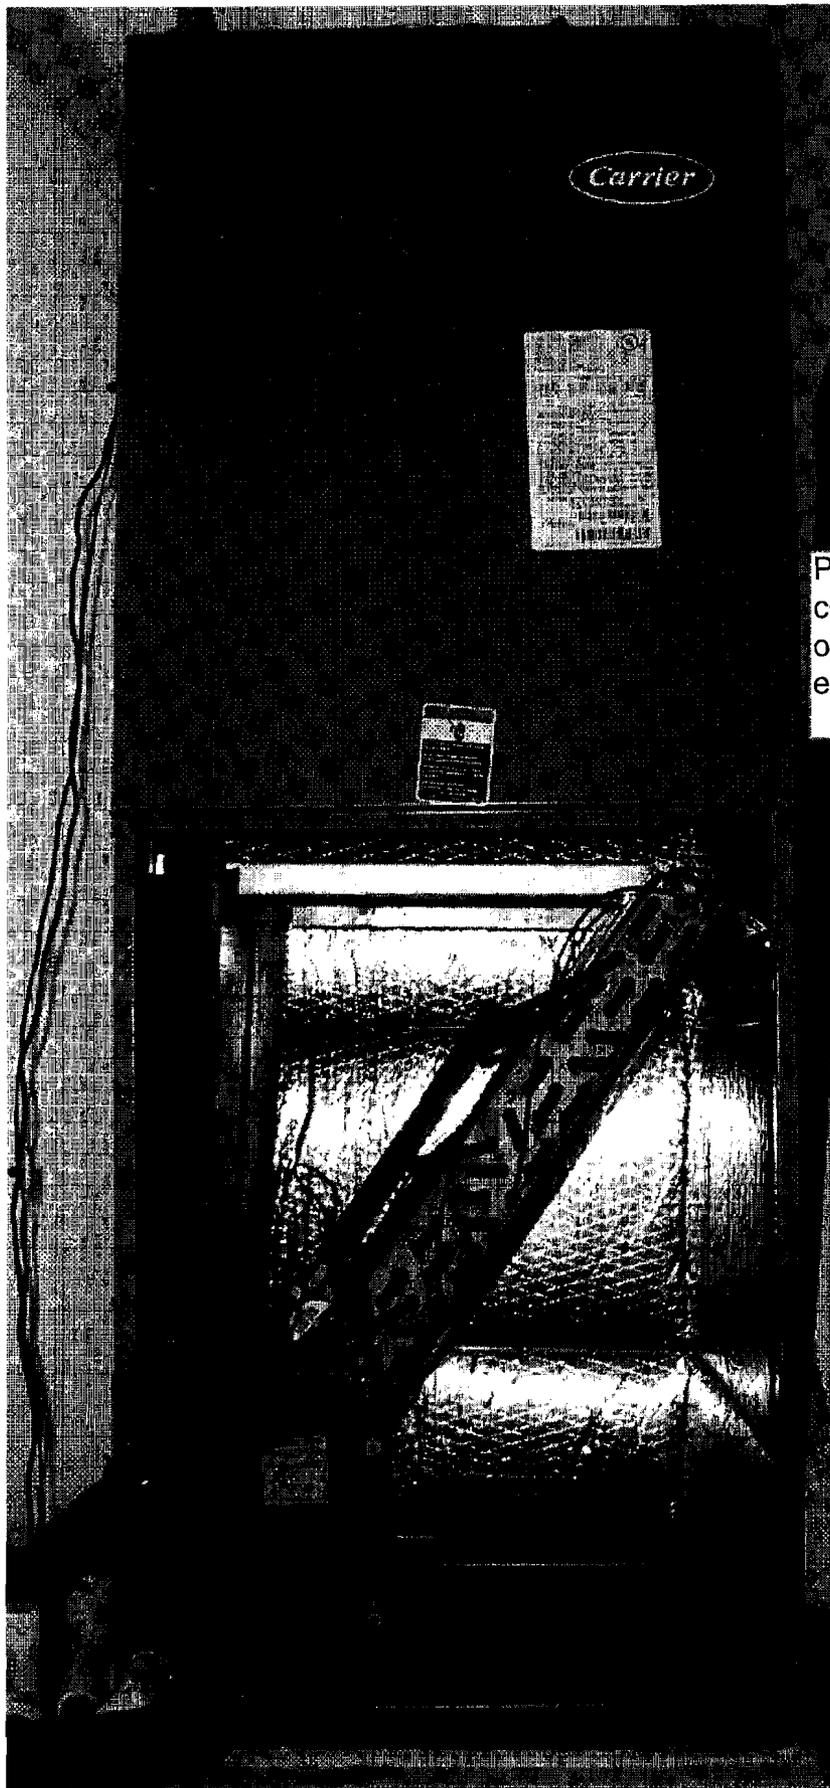
Photograph of corrosion on one of the replaced evaporator coils.

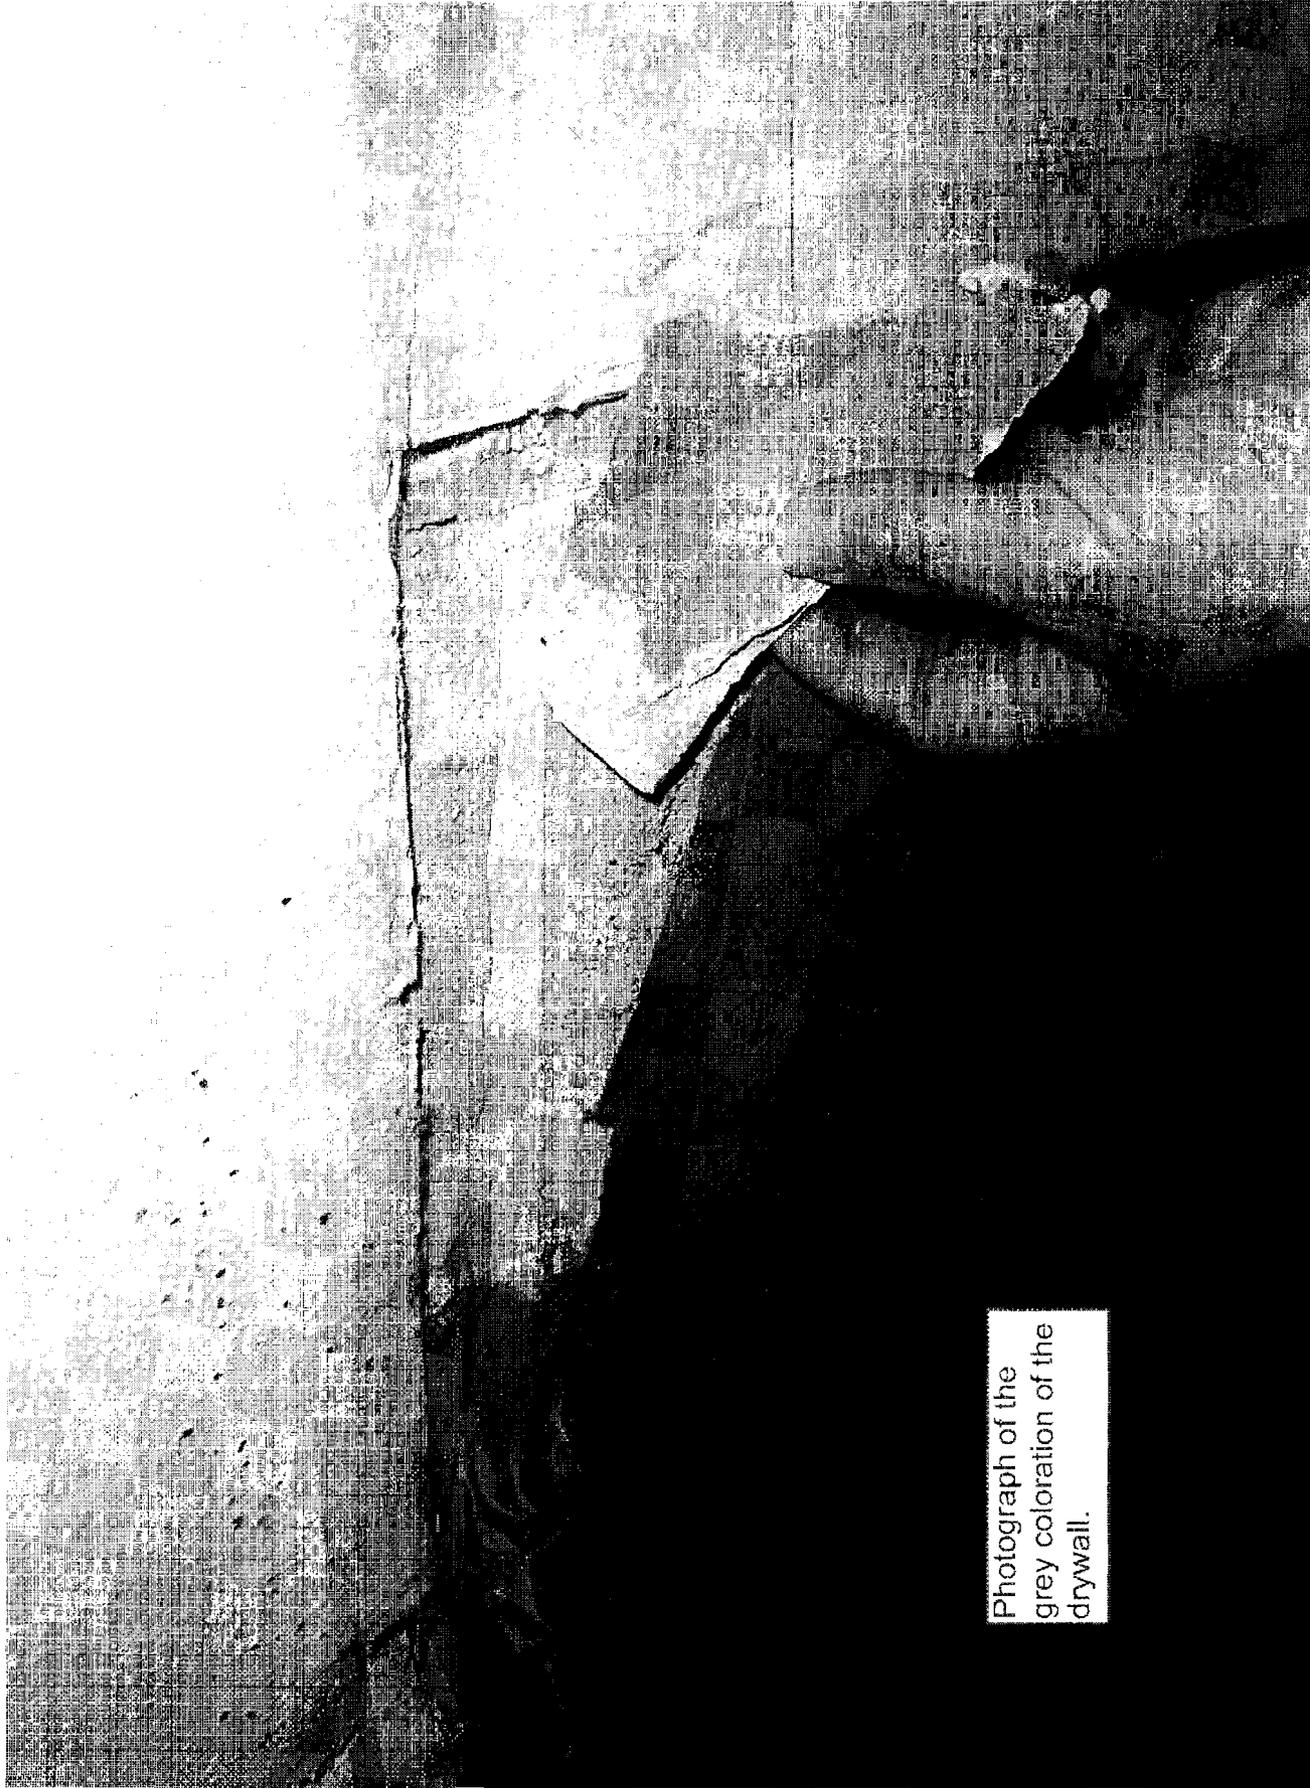
Photograph of the  
grey coloration of the  
drywall.

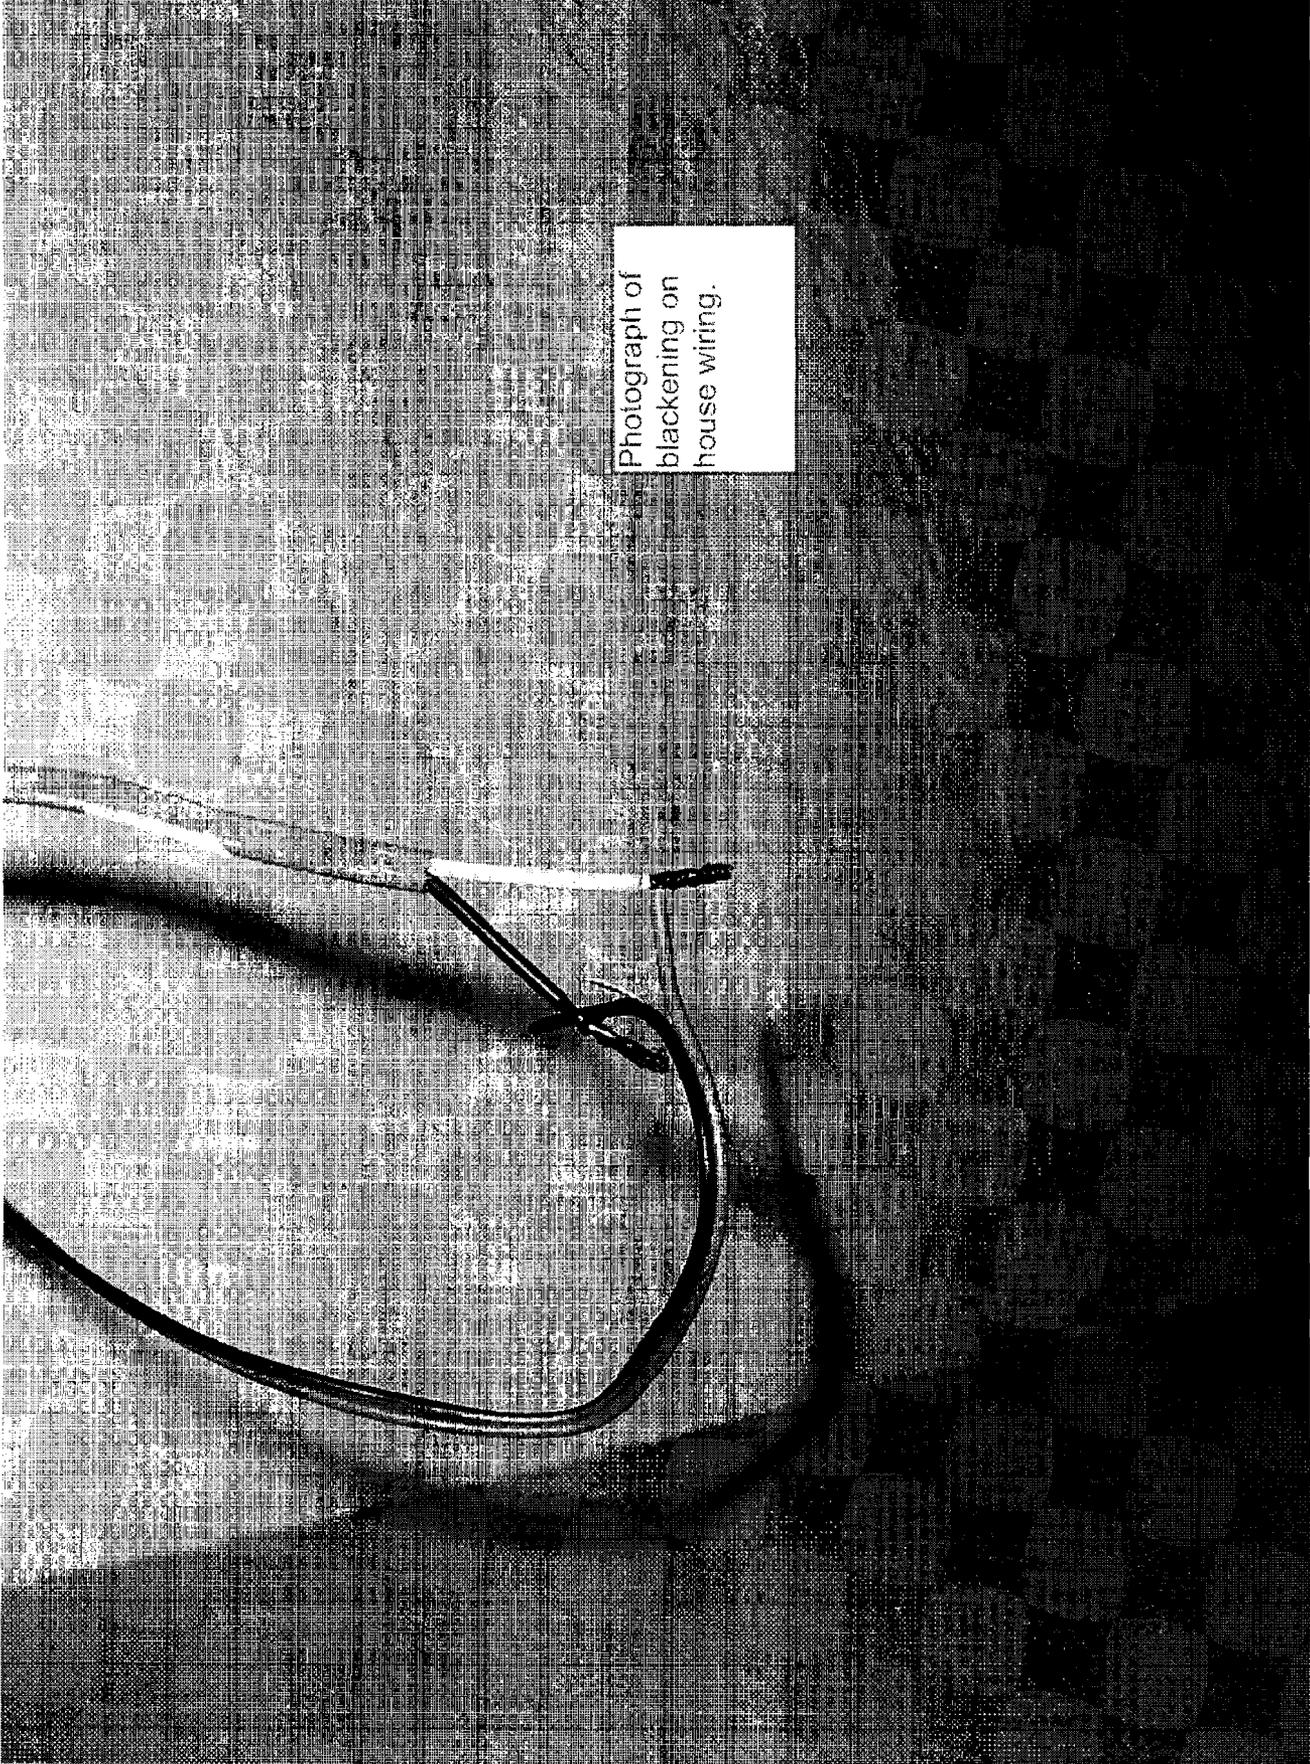
Photograph of  
blackening on  
house wiring.

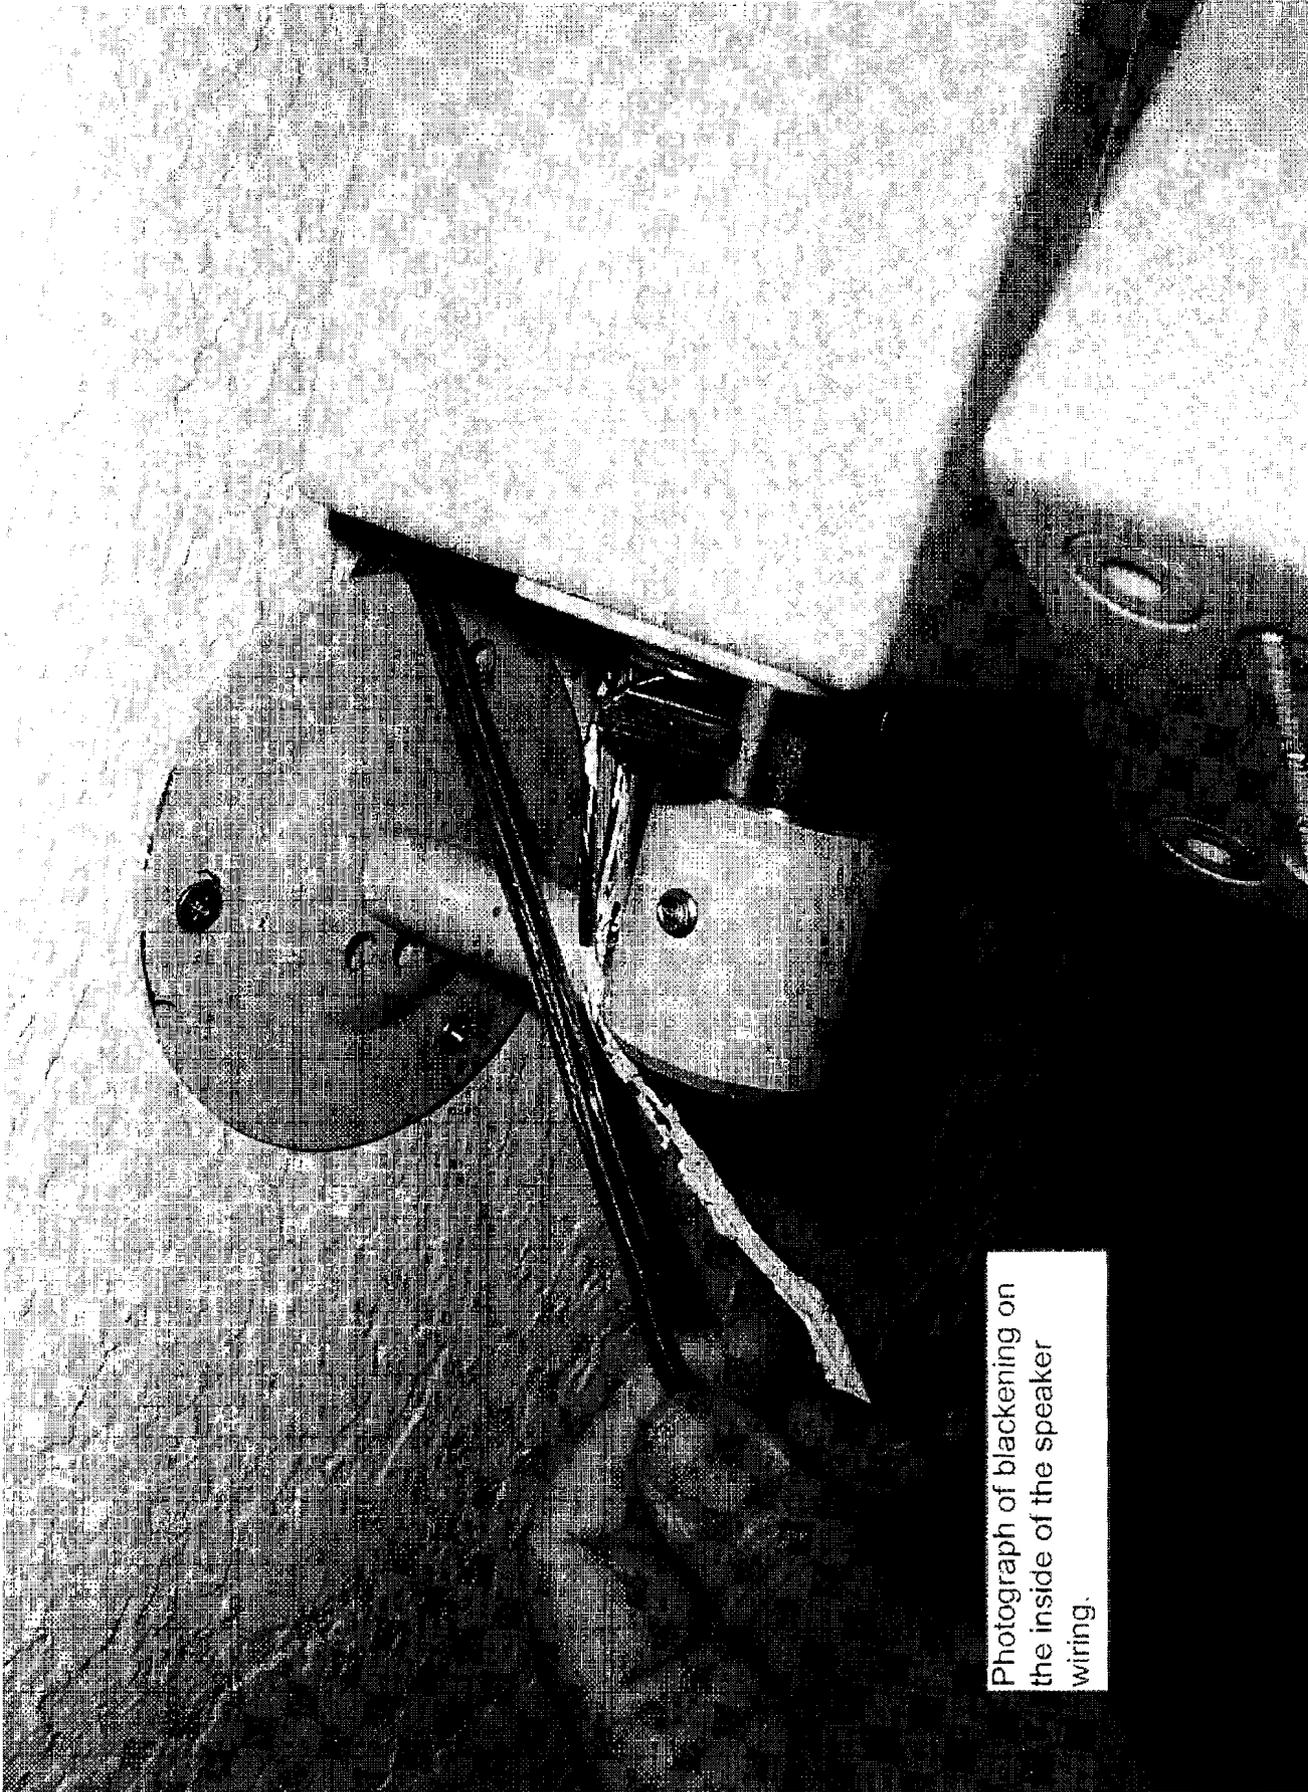
Photograph of blackening on the inside of the speaker wiring.
