090810CBB1946

This in-depth-investigation was initiated as follow-up to a CPSC generated incident report indicating that a consumer residing in a community allegedly containing Chinese drywall has reported that he has not experienced any obvious health related problems nor has had issues with malfunctioning appliances in his home.

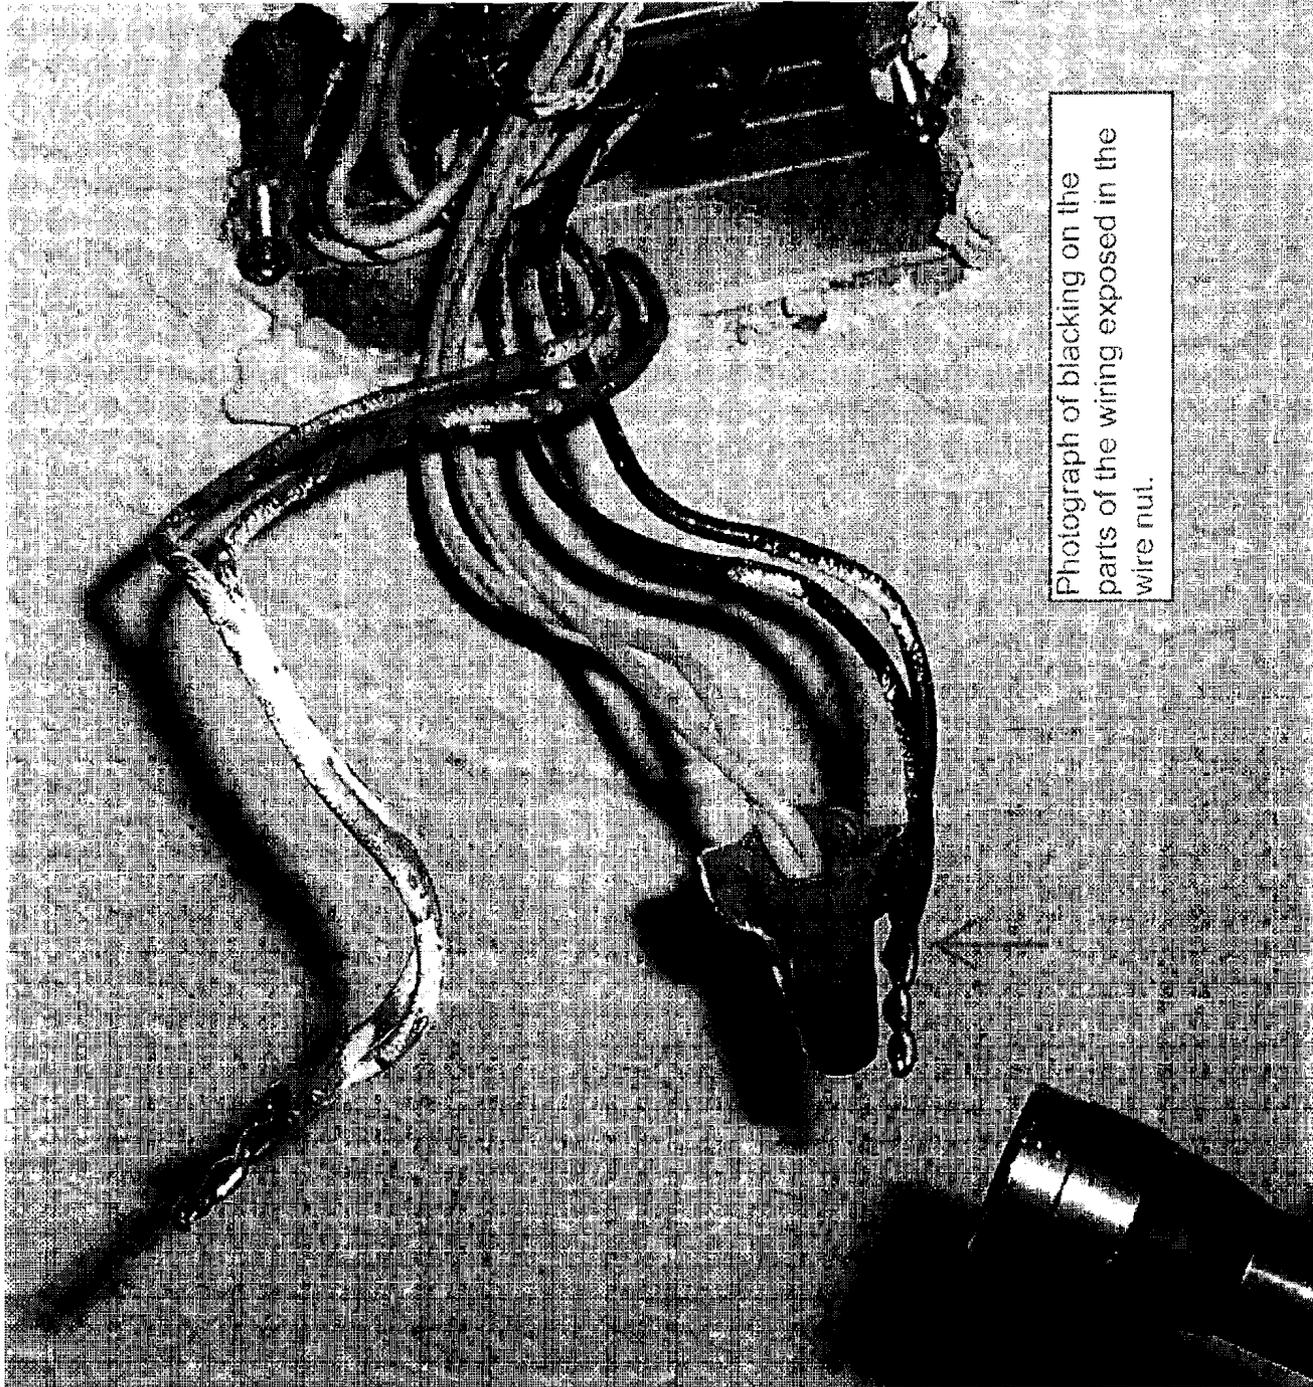
Photograph of blacking on the parts of the wiring exposed in the wire nut.

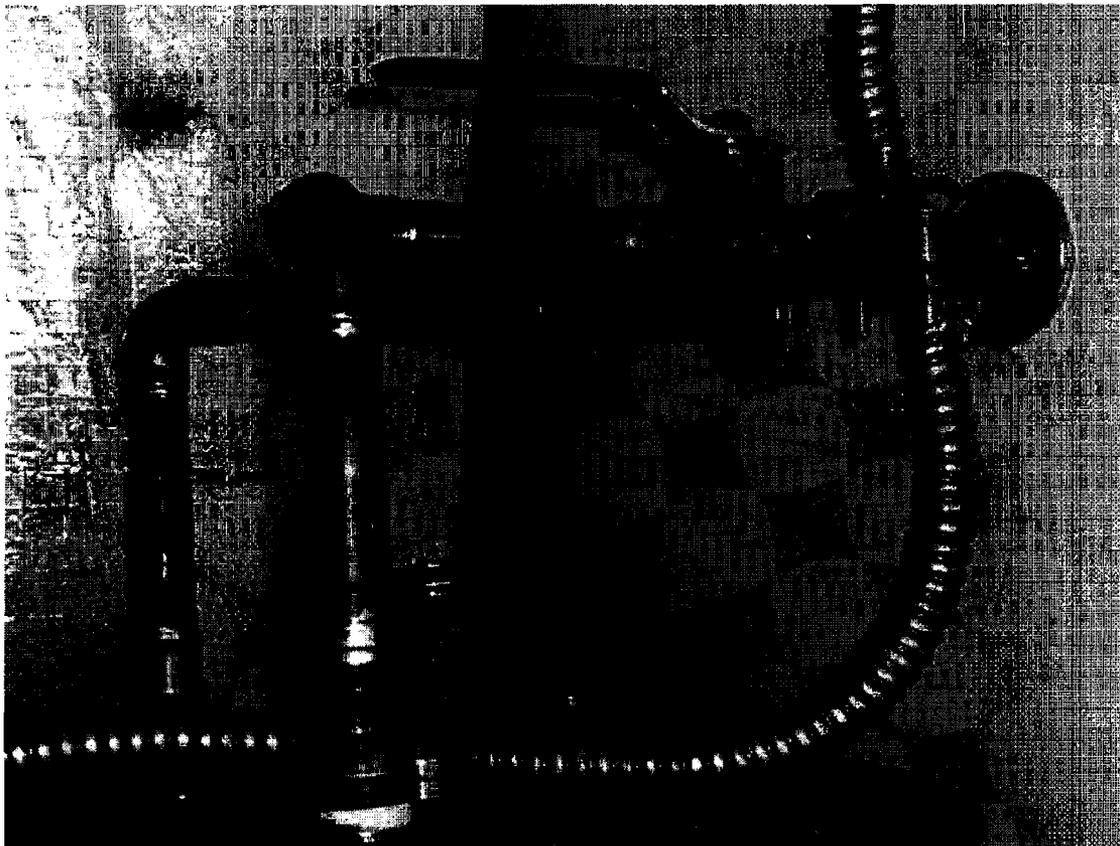
Corrosion occurs in the holes of the shower head.

Photo 5 shows blackening and corrosion in the shower head.

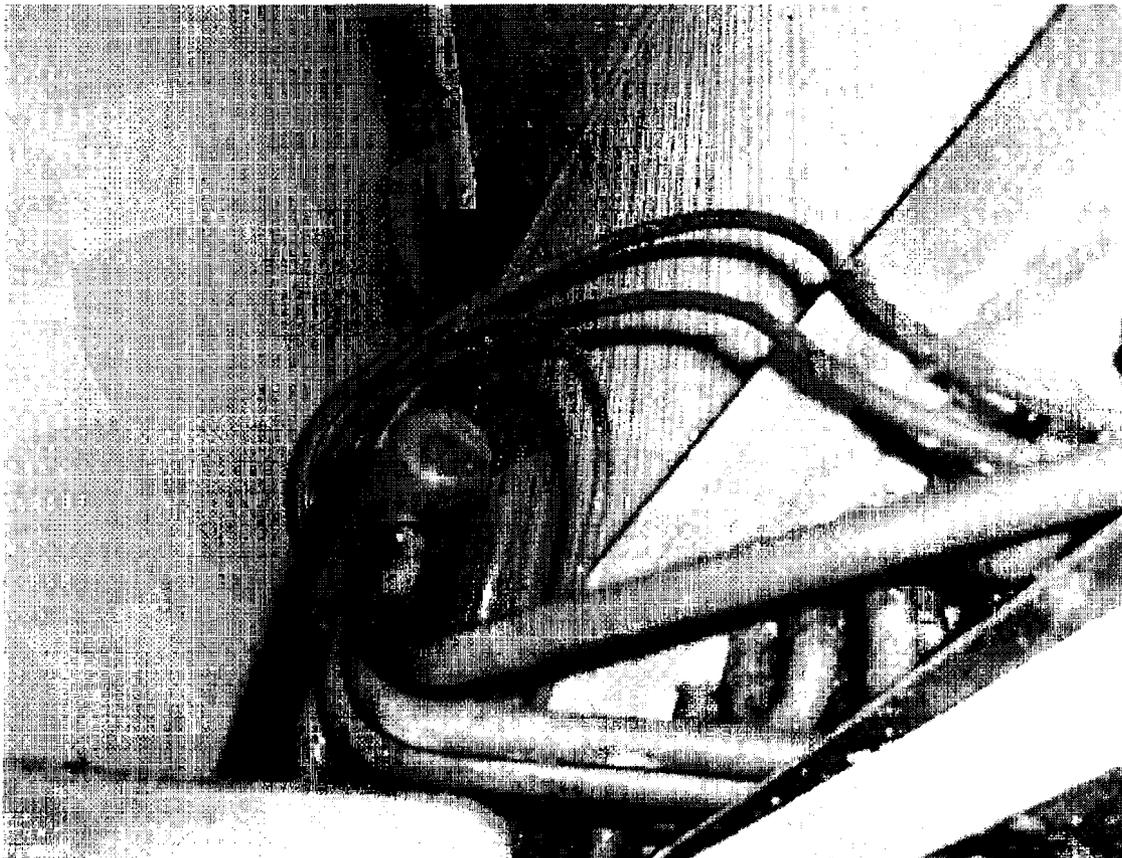
Photo 9 shows some corrosion on the copper evaporator coils of the air conditioning unit.

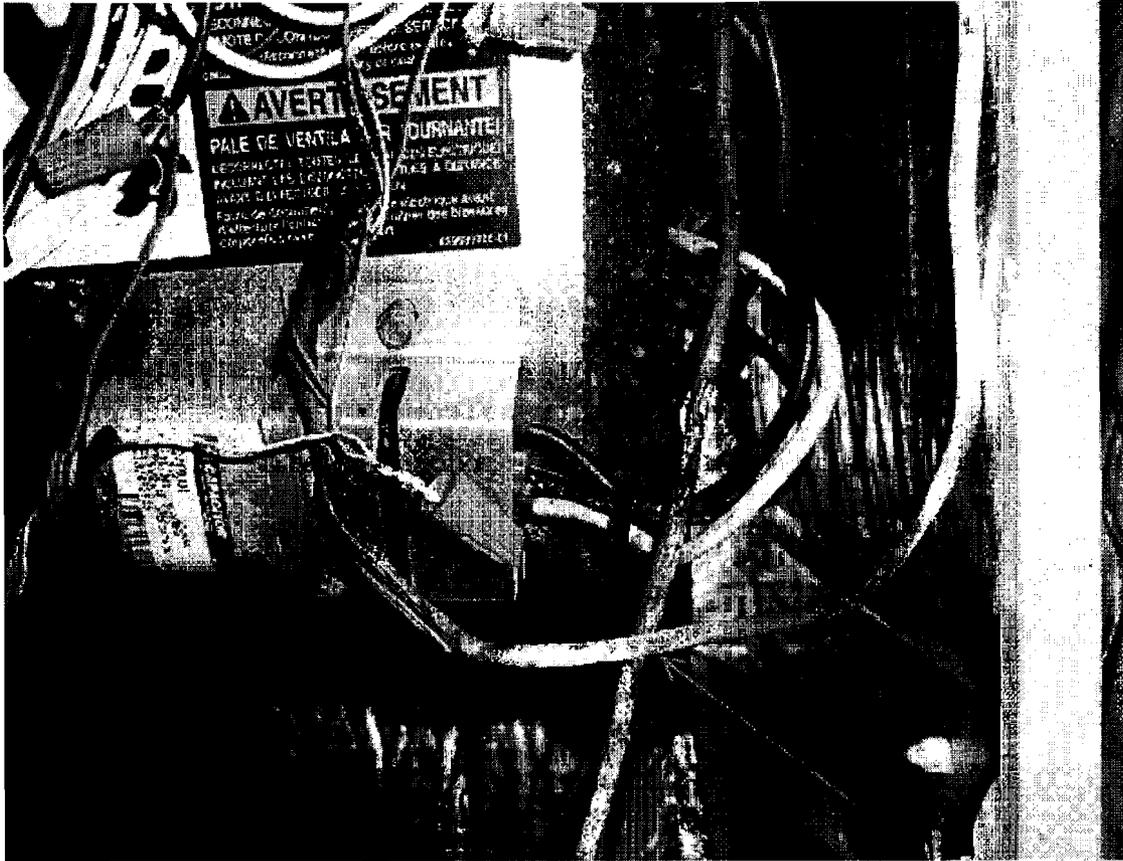
Photo 10 shows a closer view of the evaporator coils beginning to corrode.

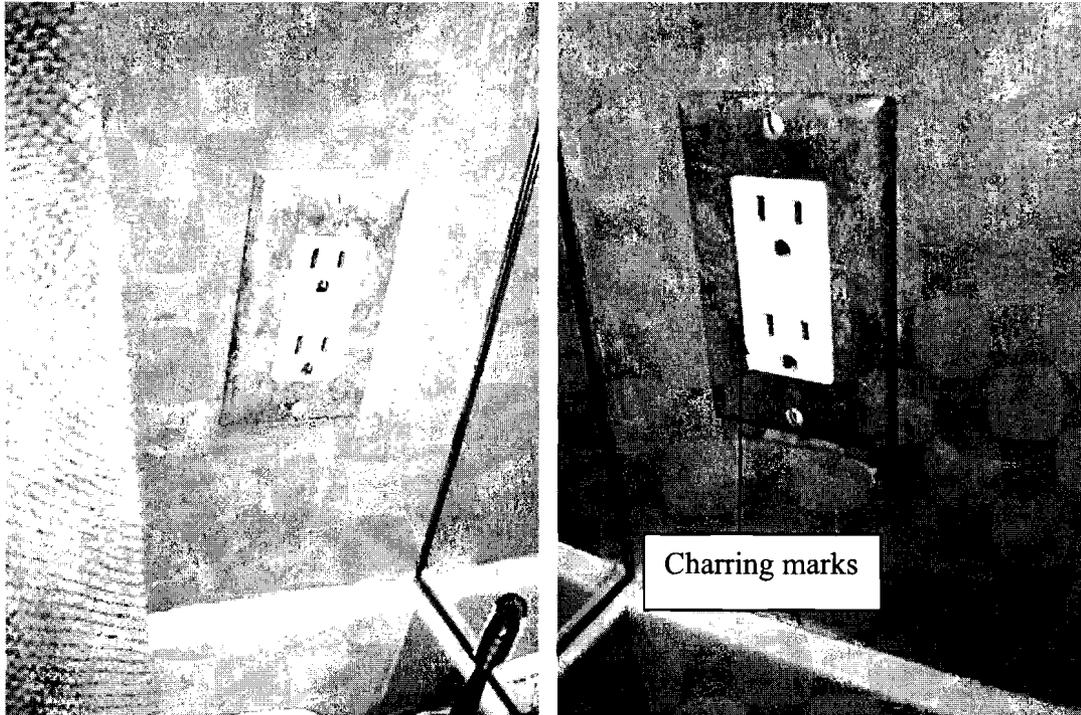
Exhibit A-17 is a view of the outlet being used by the hair dryer on the left, and the replacement outlet on the right that began smoking and started to melt. The outlet cover for the right outlet is from the incident and charring marks can be seen near the outlet receptical.
