1. TASK NUMBER 980320CWE7133		2. INVESTIGATOR'S ID 8021		EPIDEMIOLOGIC INVESTIGATION REPORT
3. OFFICE CODE 860	4. DATE OF ACCIDENT YR MO DAY 980319	5. DATE INITIATED YR MO DAY 980320

6. SYNOPSIS OF ACCIDENT OR COMPLAINT Three victims including a 15 year old female, a 16 year old female and a nine year old male were riding an amusement ride when they were ejected from their car. The 15 year old female was pronounced DOA and the other two victims were treated and released. The cause of death of the 15 year old victim was severe head injuries.

PRE-INCIDENT

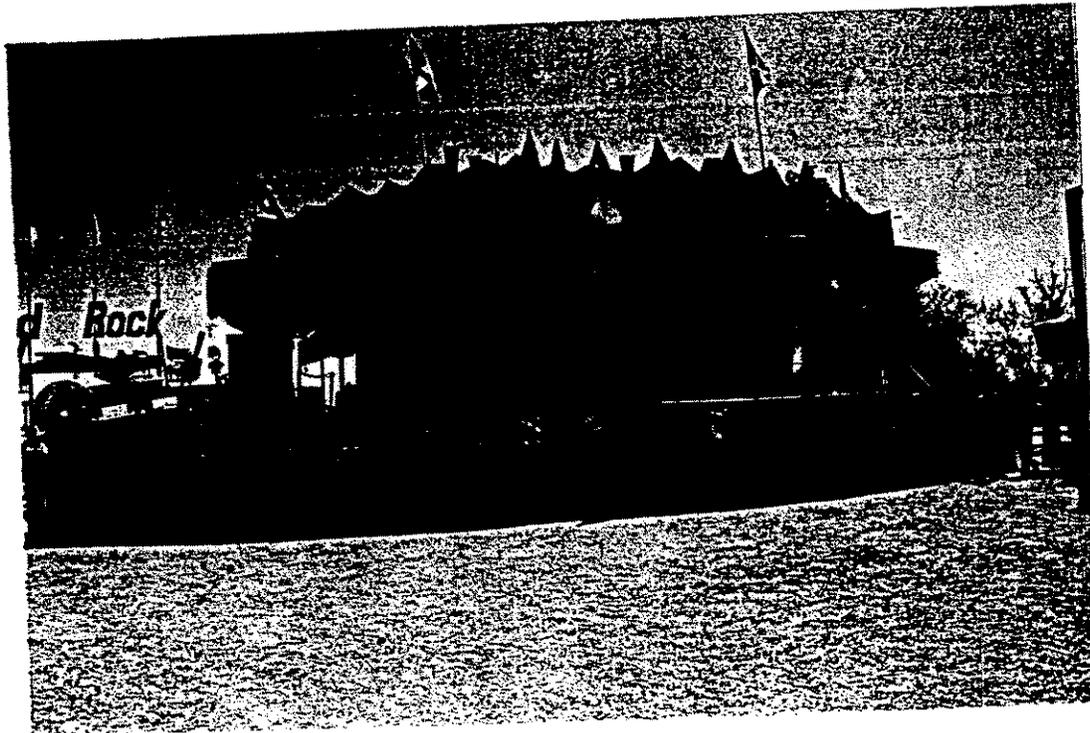
Photo shows front view of Himalaya amusement ride. The ride is own and operated by B & B Amusements 4491 S. 4th Ave., Yuma, AZ 85365. (520-726-9522) The manufacturer is Reverchon in France. B & B Amusements was operating the ride at the Travis County Livestock and Rodeo Show in Austin, Texas. B & B Amusements reportedly bought the ride new in 1984 and has owned it ever since.

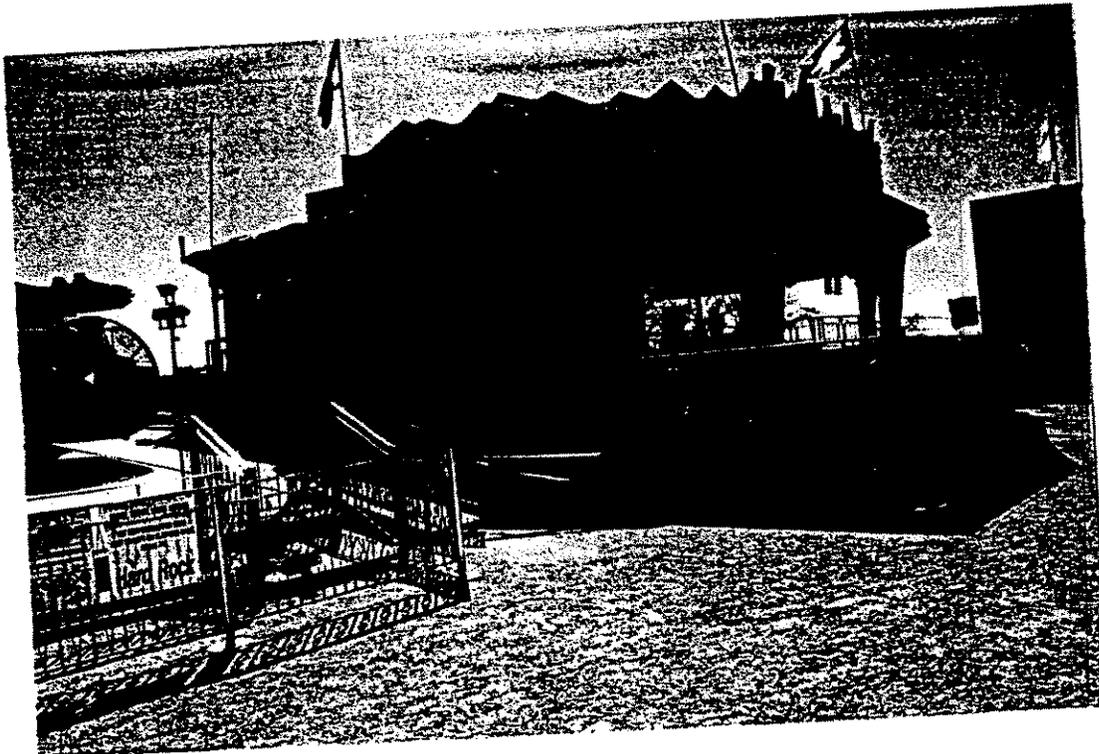
Photo shows
another view of
the Himalaya
amusement ride.
The ride was
reportedly last
used in October of
1997 at the Lake
Davis Fair in
California. The
ride allegedly had
been in Yuma, AZ
since then and
Austin was the
first stop in
1998.

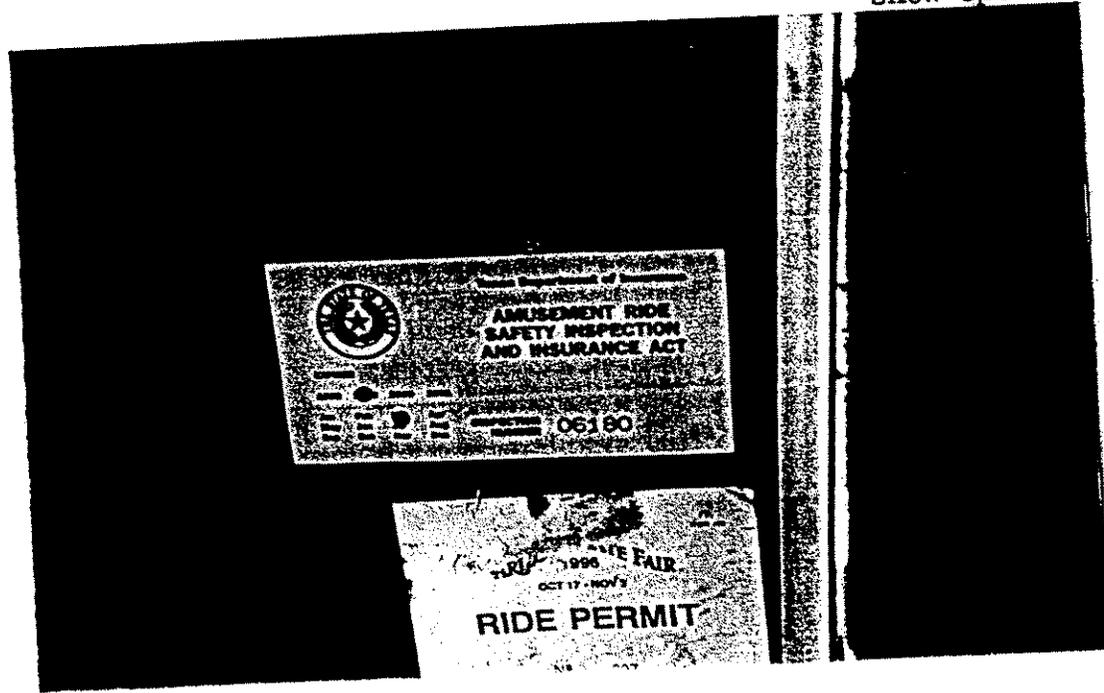
Photo shows the inspection permit which was required by the Texas Dept. of Insurance. The permit was located on the window of the ride operator station. The Texas Dept. of Insurance requires rides to have an annual inspection, sufficient insurance and a \$20.00 filing fee per ride. Bob Gill & Associates, Brandon, Florida was hired to perform the inspection which was performed on 3/9/98 before the show opened.

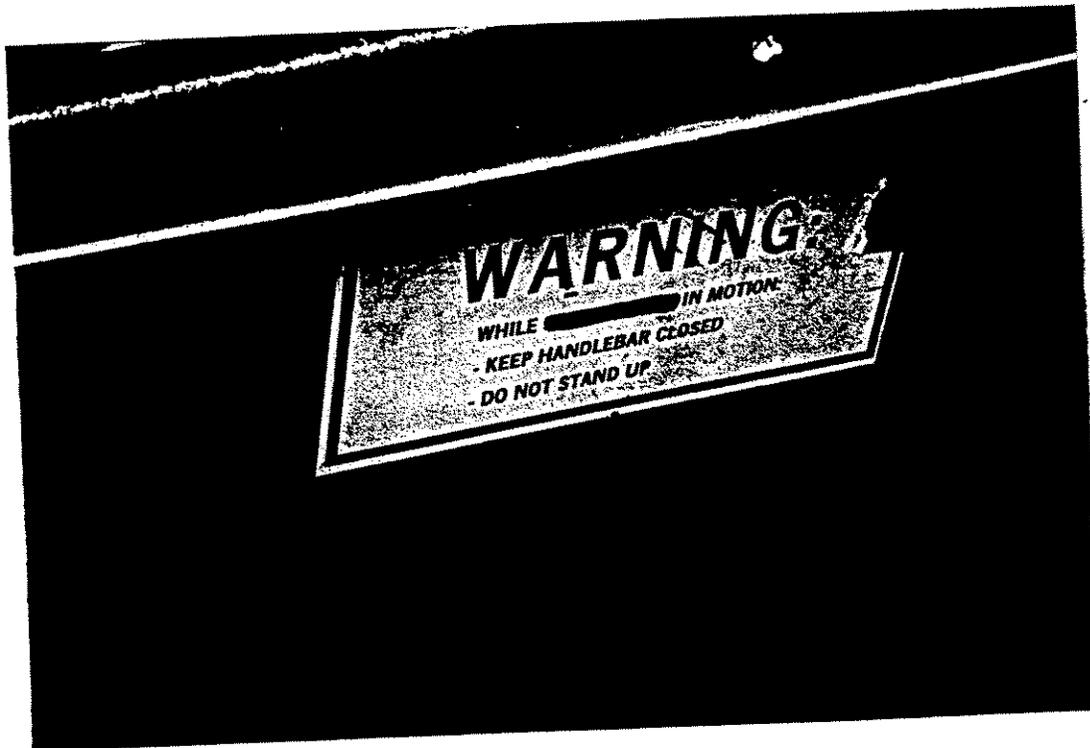
Photo shows a warning statement on the back of all 24 cars associated with this ride. This statement is visible to riders in cars next in line. The word "scrambler" is blacked out.

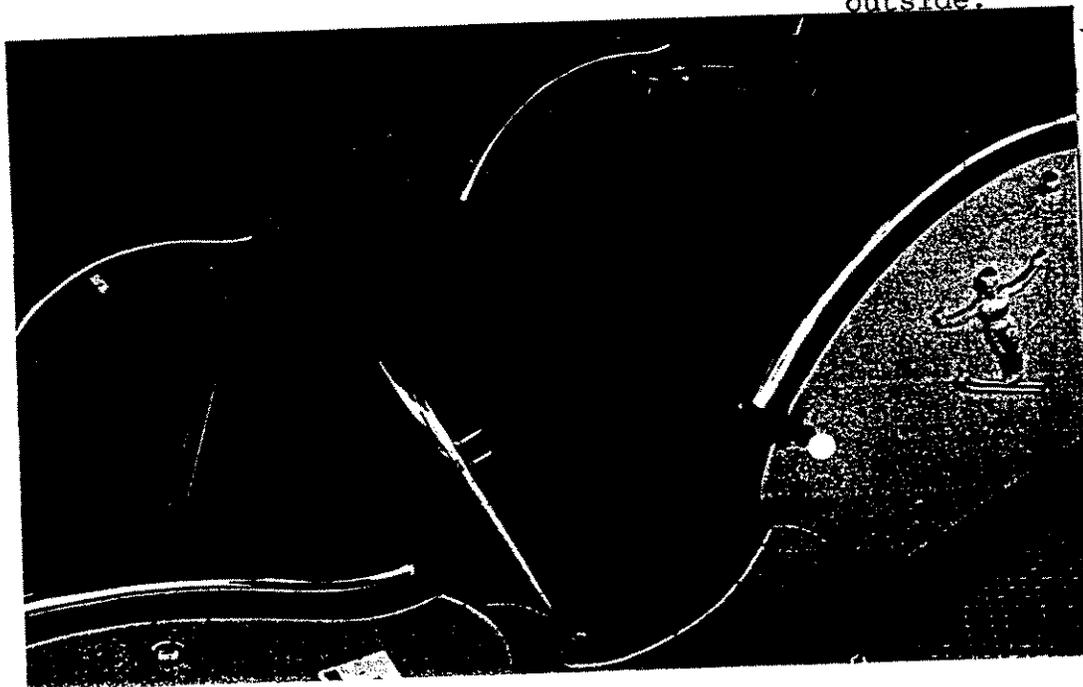
Photo shows an individual car of the ride. The lap bar has been pushed forward to allow riders to enter the ride. The nine year old male victim was first into the ride, then the 16 year old female victim was in the middle and then the 15 year old female victim who was killed was on the outside. The cars are loaded from the smallest to the largest because the force of the ride pushes everyone to the outside.

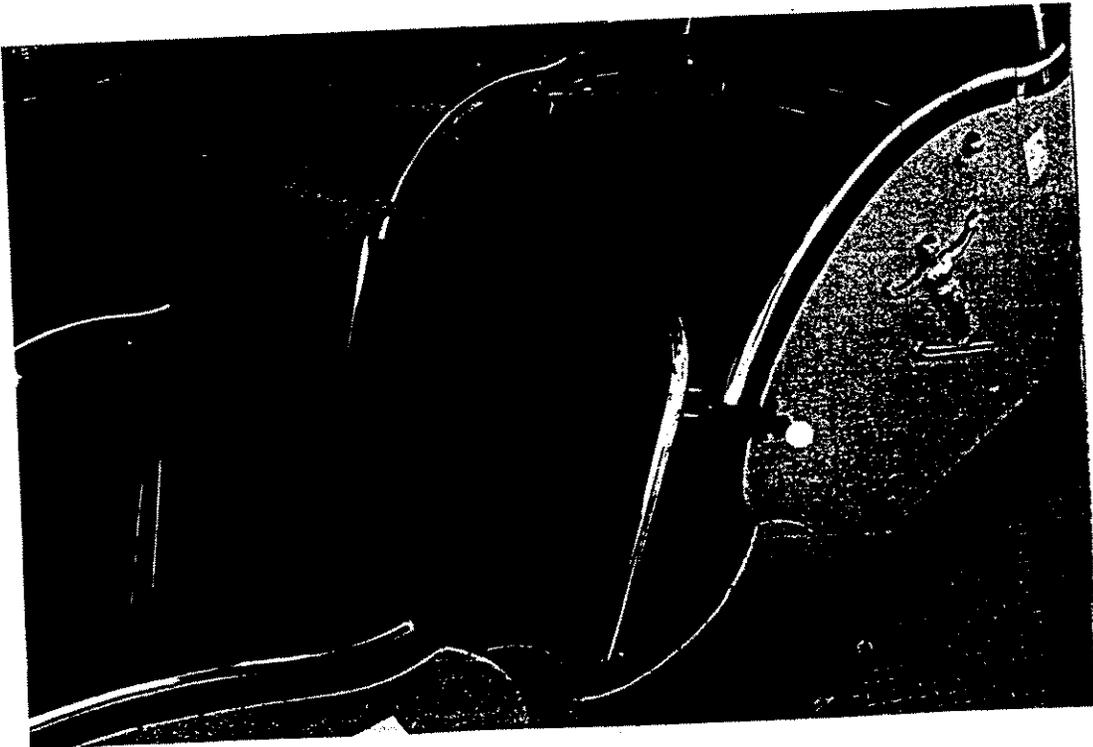
Photo shows an individual car with the bar being closed after the riders have been seated. The nine year old on the inside weighed approx. 100 pounds, the 16 year old in the middle weighed approx. 155 pounds and the 15 year old victim on the outside who was killed weighed 185 pounds and was 68 inches tall.

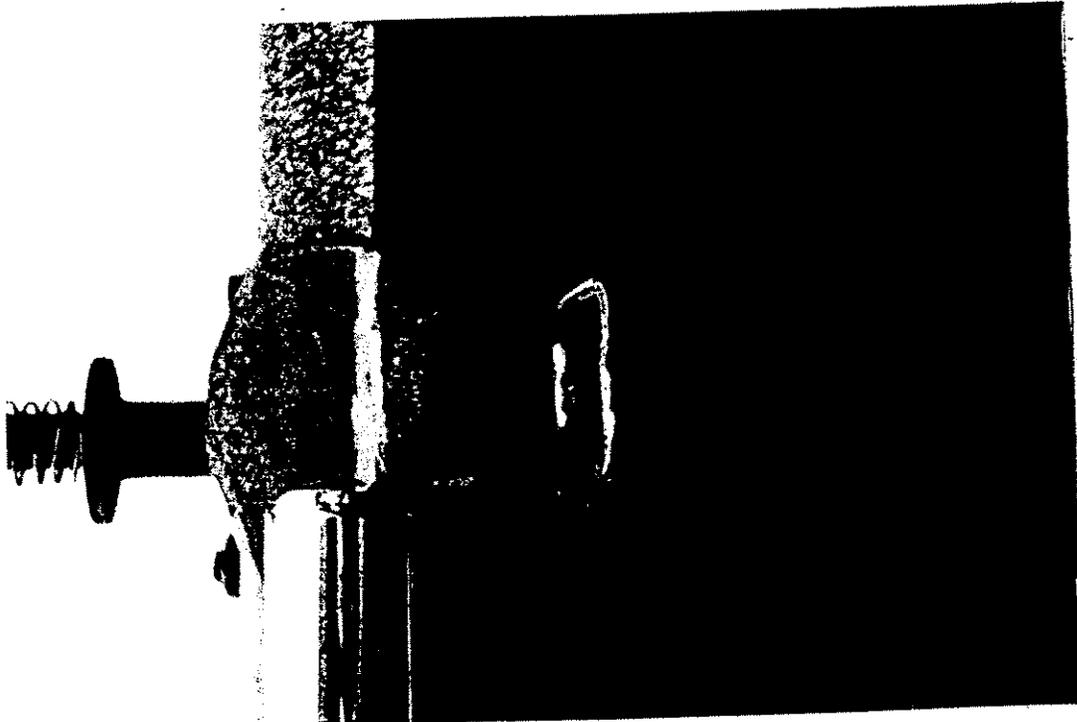
Photo shows the locking mechanism on the outside of each car. This mechanism is located just outside the car and next to the rider on the outside. The 15 year old victim was setting next to this mechanism when the incident occurred. This photo is taken looking down into this mechanism which locks the lap restraining bar into place.

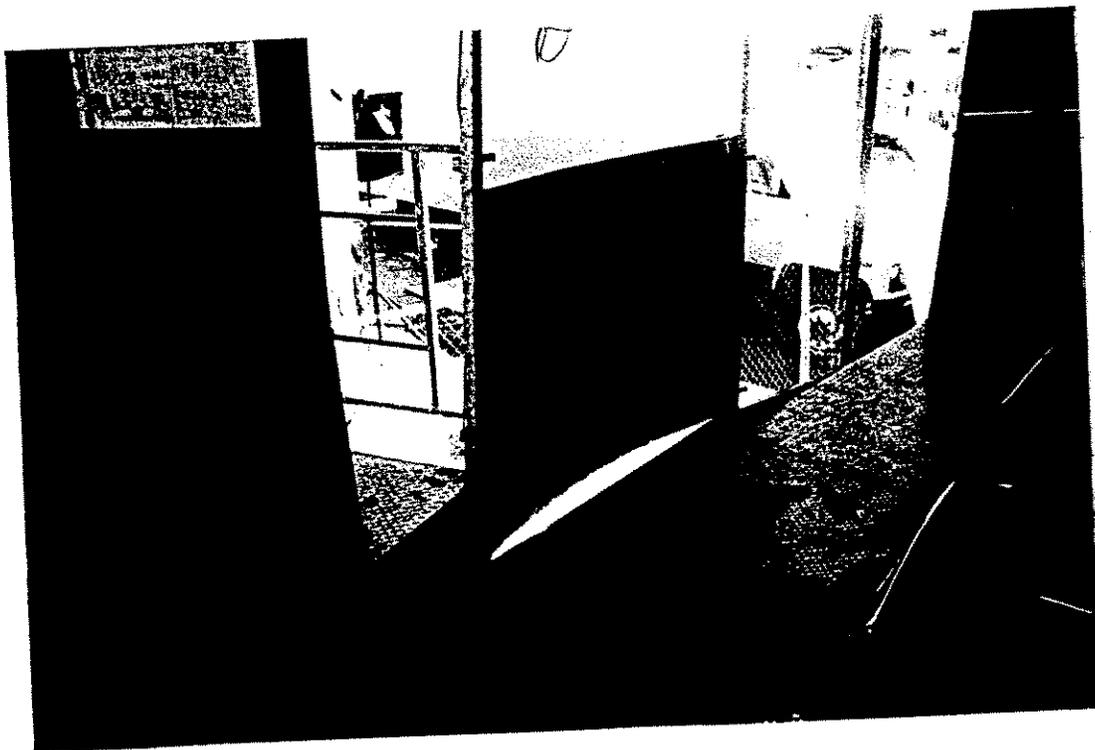
PICTURE
NO. 19
DESCRIPTION
Photo shows
another view of
the area where the
victims landed.
This ride travels
clockwise and the
incident occurred
at the approx.
nine o'clock area.
The ride travels
on a circular
track at a tilted
angle. It also
has rises and dips
and the victims
were thrown out
just as the ride
rises up. The car
the victims were
in came to a stop
at the 6 o'clock
area.
