090810CBB1946

This in-depth-investigation was initiated as follow-up to a CPSC generated incident report indicating that a consumer residing in a community allegedly containing Chinese drywall has reported that he has not experienced any obvious health related problems nor has had issues with malfunctioning appliances in his home.

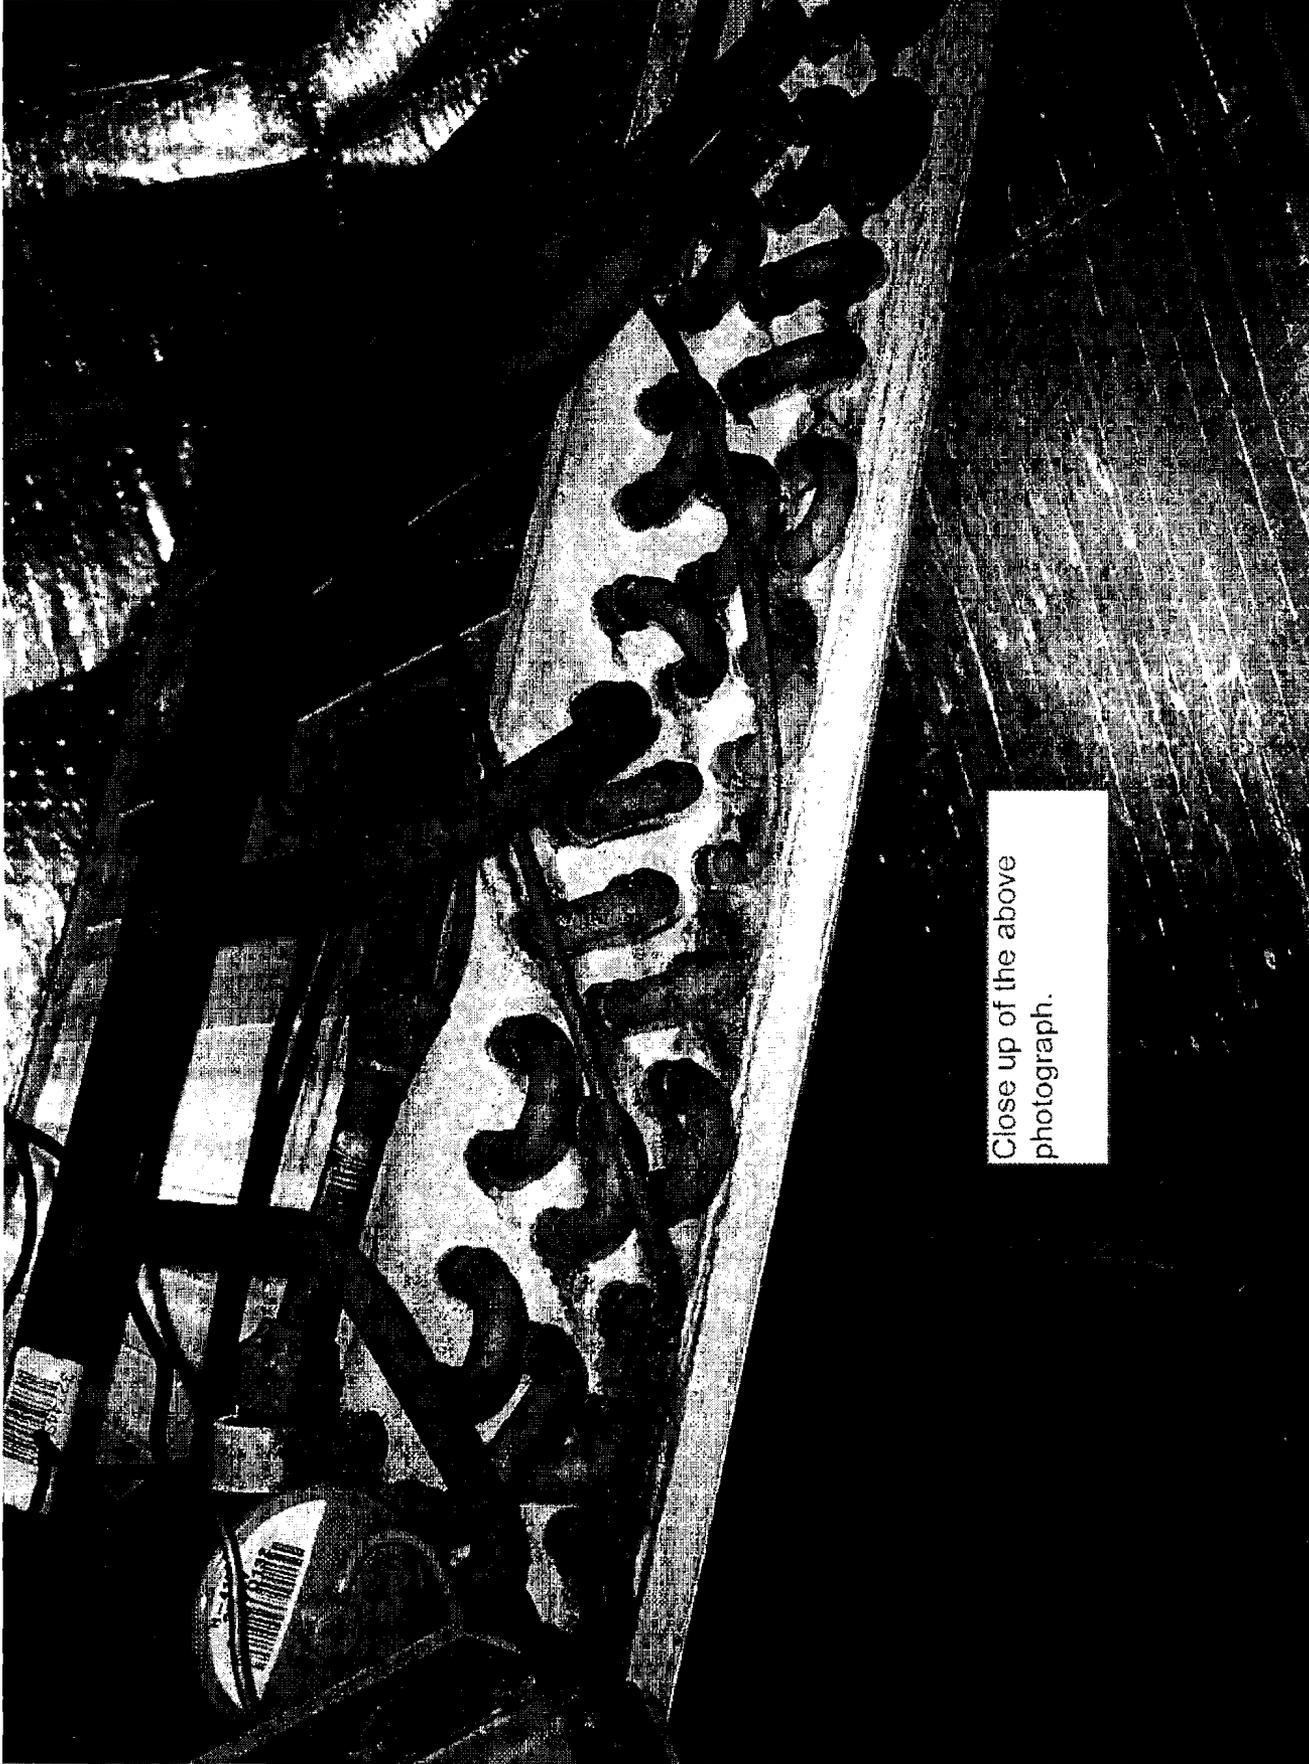
Close up of the above photograph.

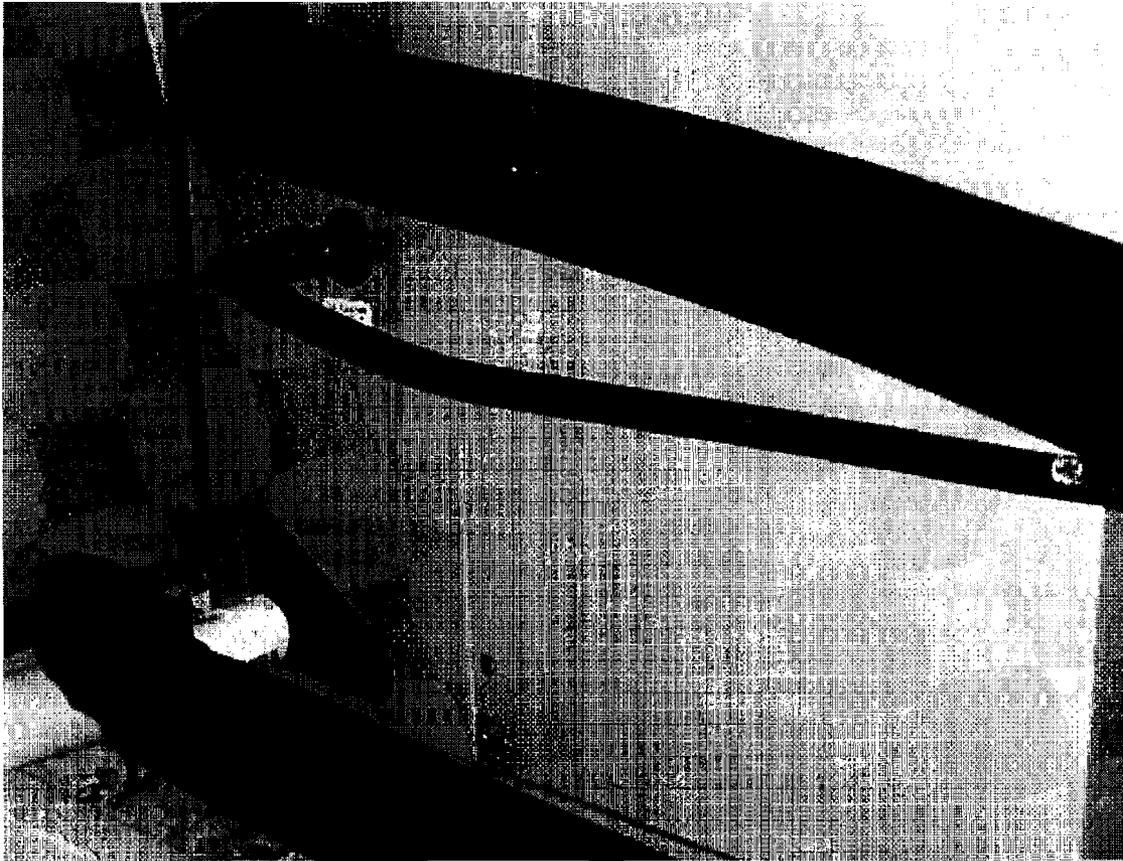
Photo 7 shows a blackening copper pipe connected to the air conditioning unit.P

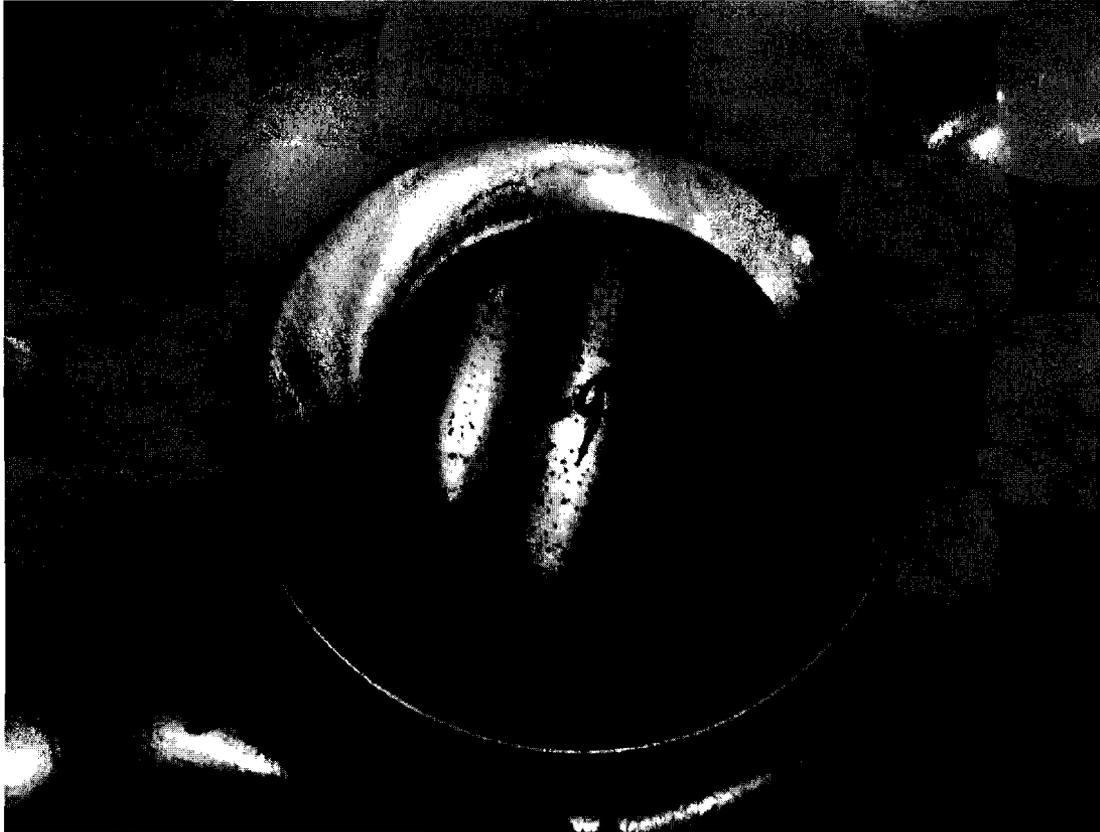
Exhibit A-5 is a view of pitting on the drain of the first floor bathroom sink.

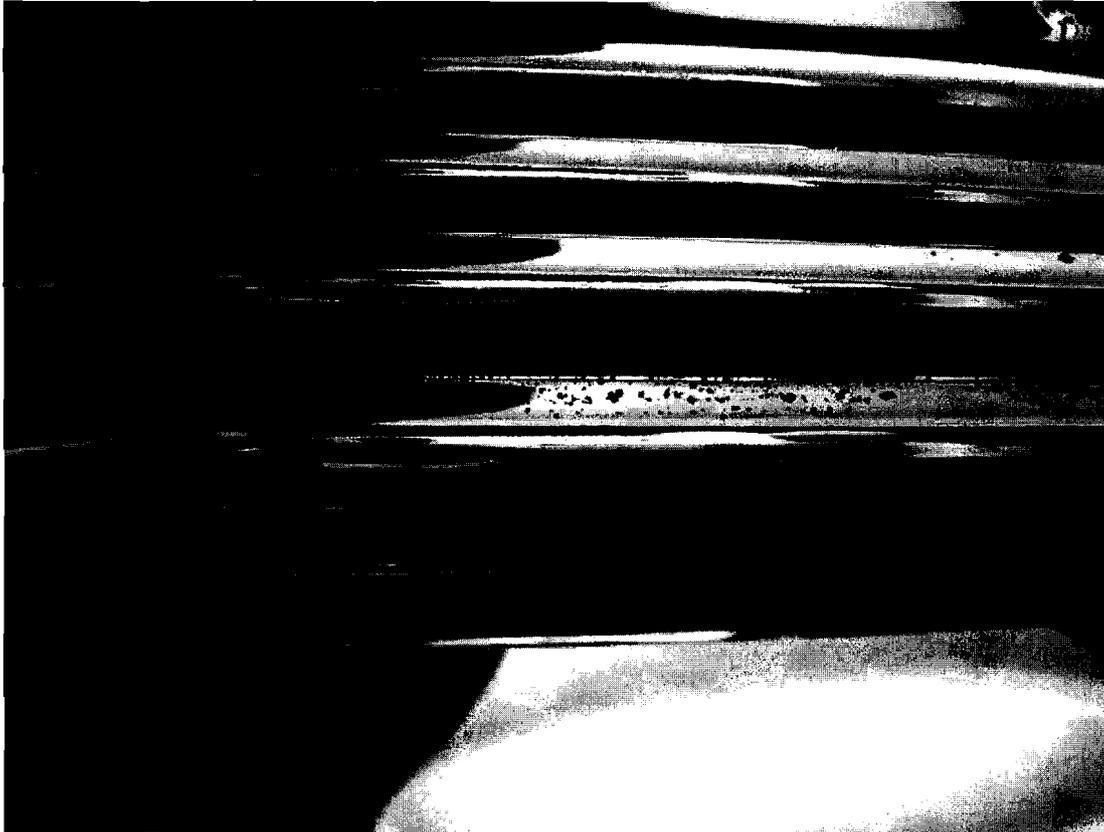
Exhibit A-6 is a view of pitting on the metal light fixture in the first floor bathroom.

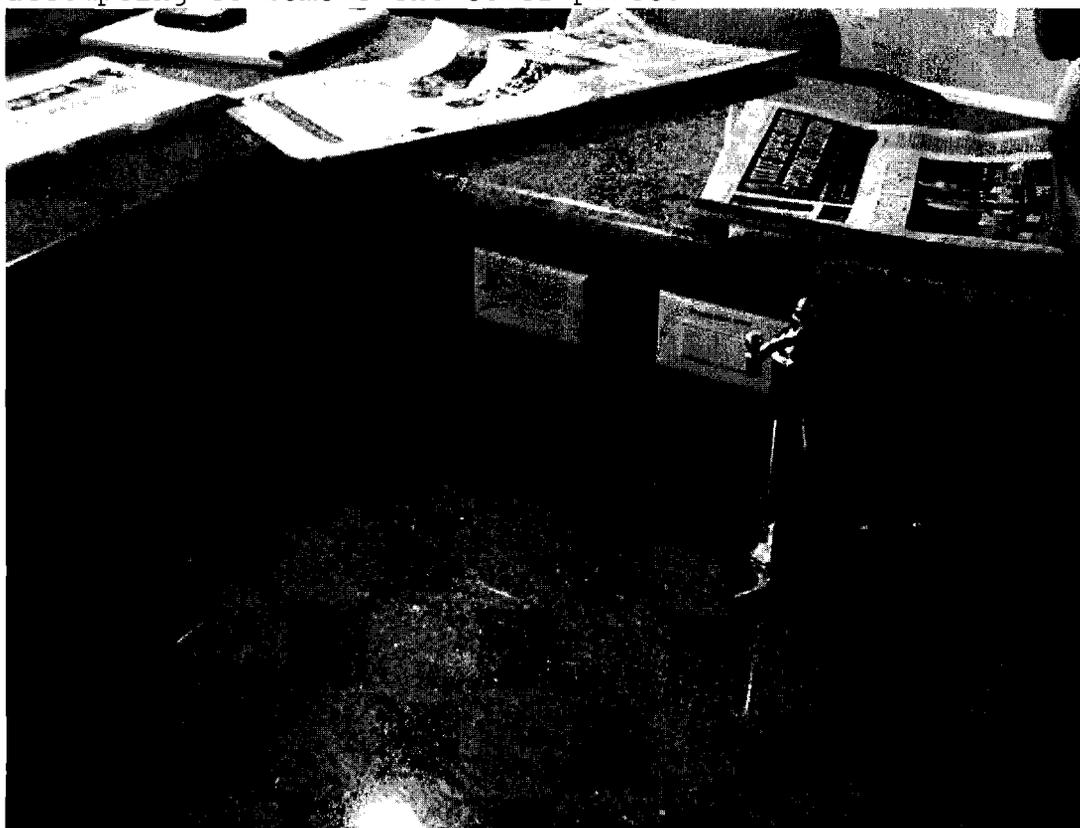
Exhibit A-11 is a view of the kitchen island outlet receptacle that shocked the consumer's husband while he was attempting to remove the cover plate.

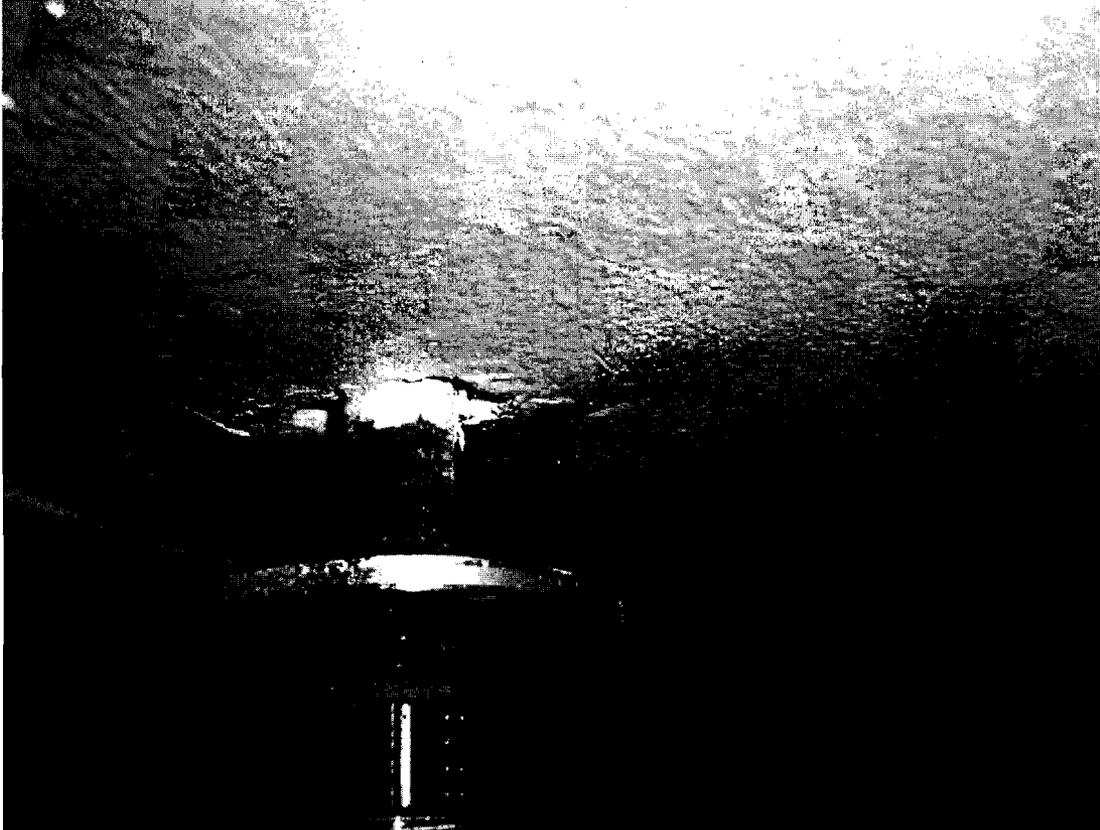
Exhibit A-14 is a view of the blackening of a copper pipe for a third floor bathroom.

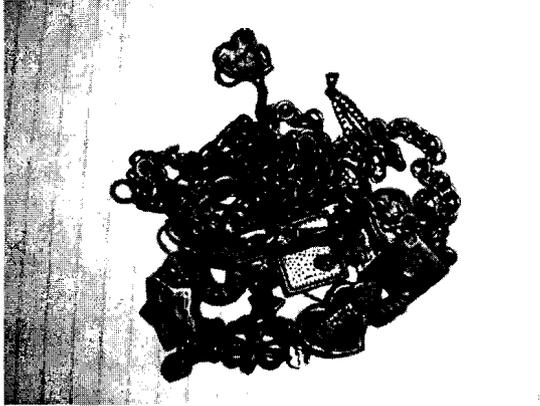
Exhibit A-15 is a view tarnished silver and gold jewelry that was cleaned in April 2009.
